Column Tests

Column Specifications and Design

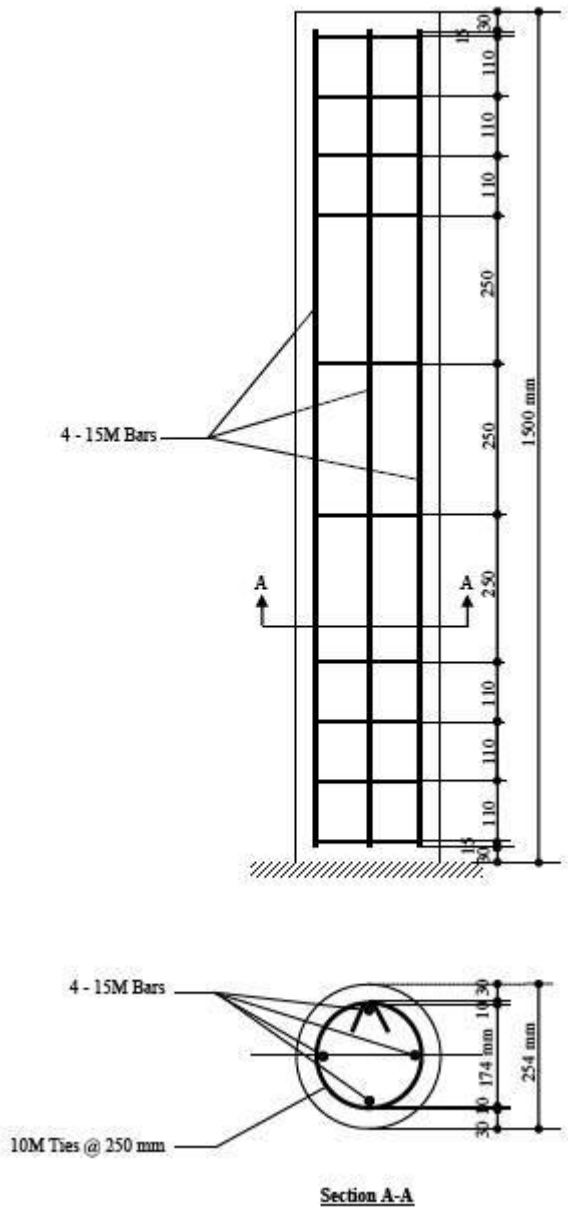
Figure 42: Column reinforcement details.

All columns had 254 mm radius and the column height was limited to 1500 mm. Based on calculations, four 15M bars were considered as the longitudinal bars, tie size was selected as 10M and tie spacing(s) was calculated as 250 mm (center to centre) and tie hooks, were set as 135 degrees. Arrangement and configuration of the reinforcement in the column has been shown in Figure 42.

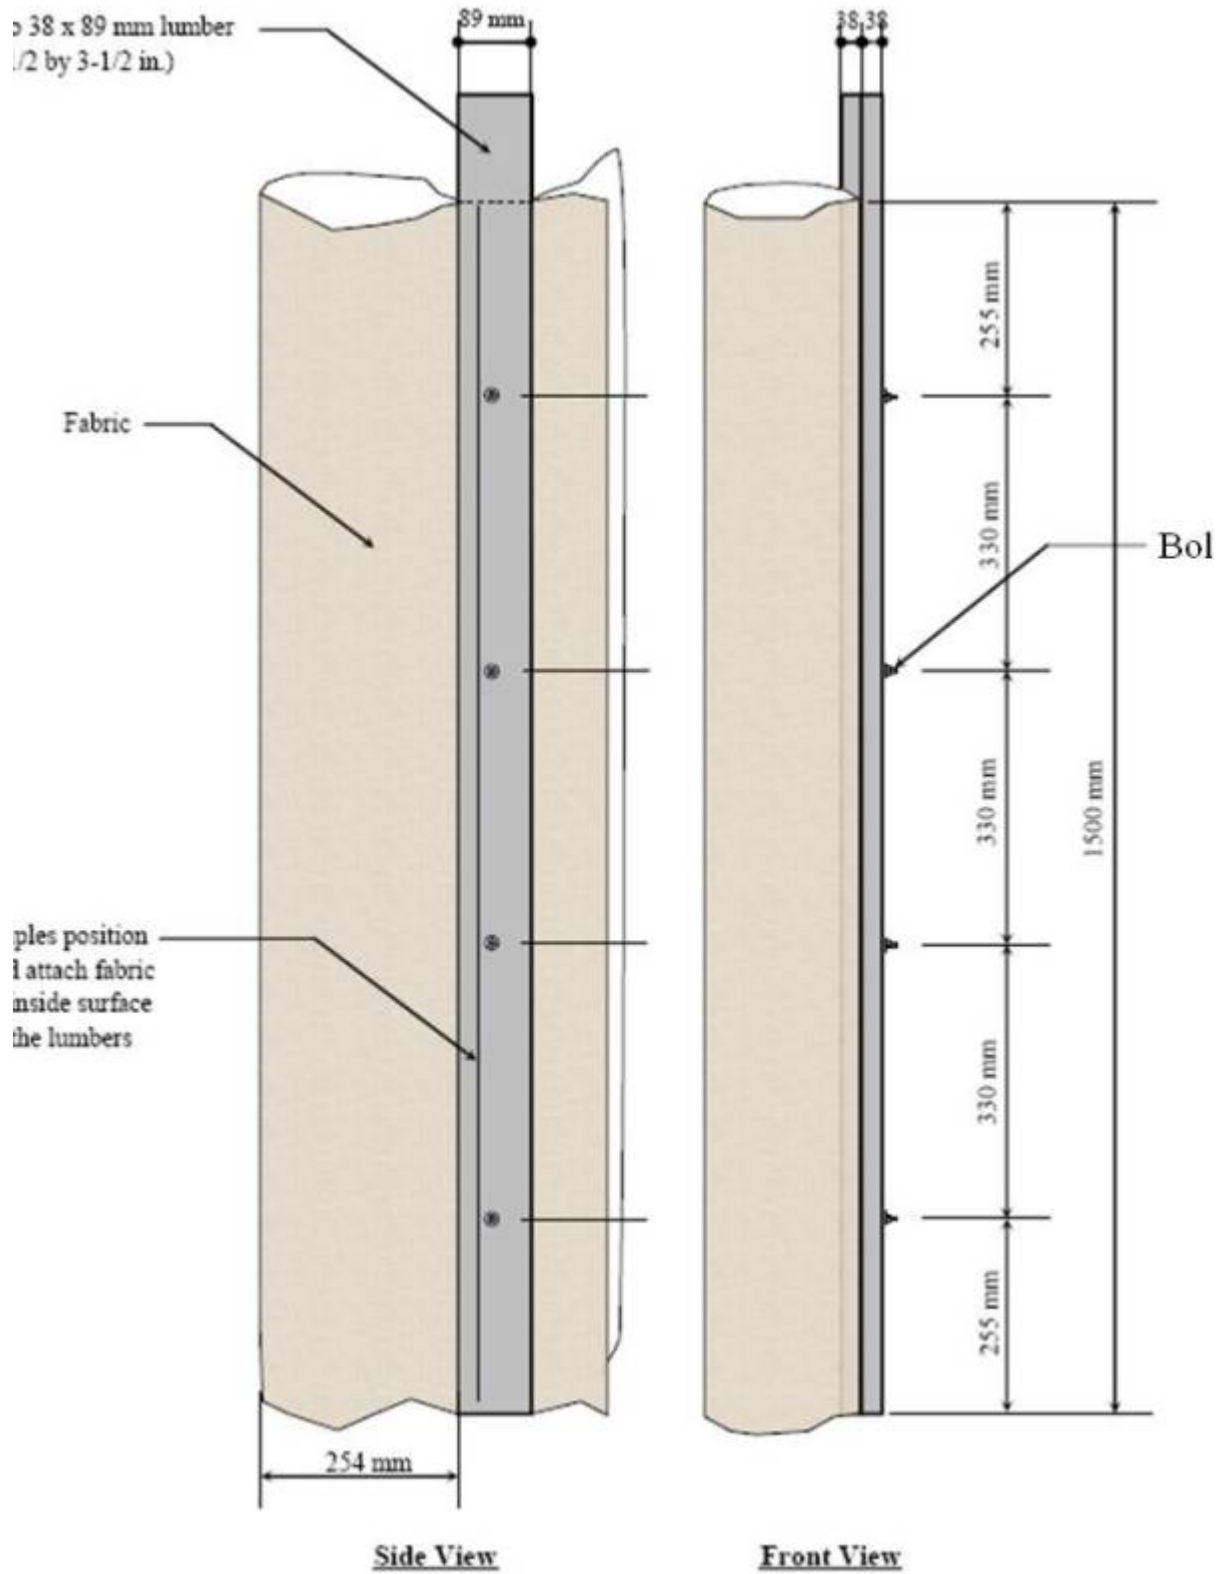
Figure 43: Configuration of the fabric formwork for reinforced concrete column.

batch. The columns were cast using normal concrete and flyash concrete. Total of 6 columns were cast. As shown in Figure 43, the formwork was essentially the same as that used to cast the earlier cylinder specimens. The formwork was made of a single, rectangular, piece of fabric sandwiched between two vertical pieces of 38 x 89 mm lumber (2" by 4"). The fabric was first fitted to create the proper diameter and stapled to the lumber pieces.

from each other (though less staples would be probably also sufficient), providing a stitch line from top to bottom of the formwork. Orientation of the stitch line can be seen in Figure 43. Stapling provided an even distribution of the hoop forces along the height of the formwork and resulted in a uniform cylindrical geometry. The variation in diameter of the column along its length was dramatically reduced as demonstrated in Figure 68.

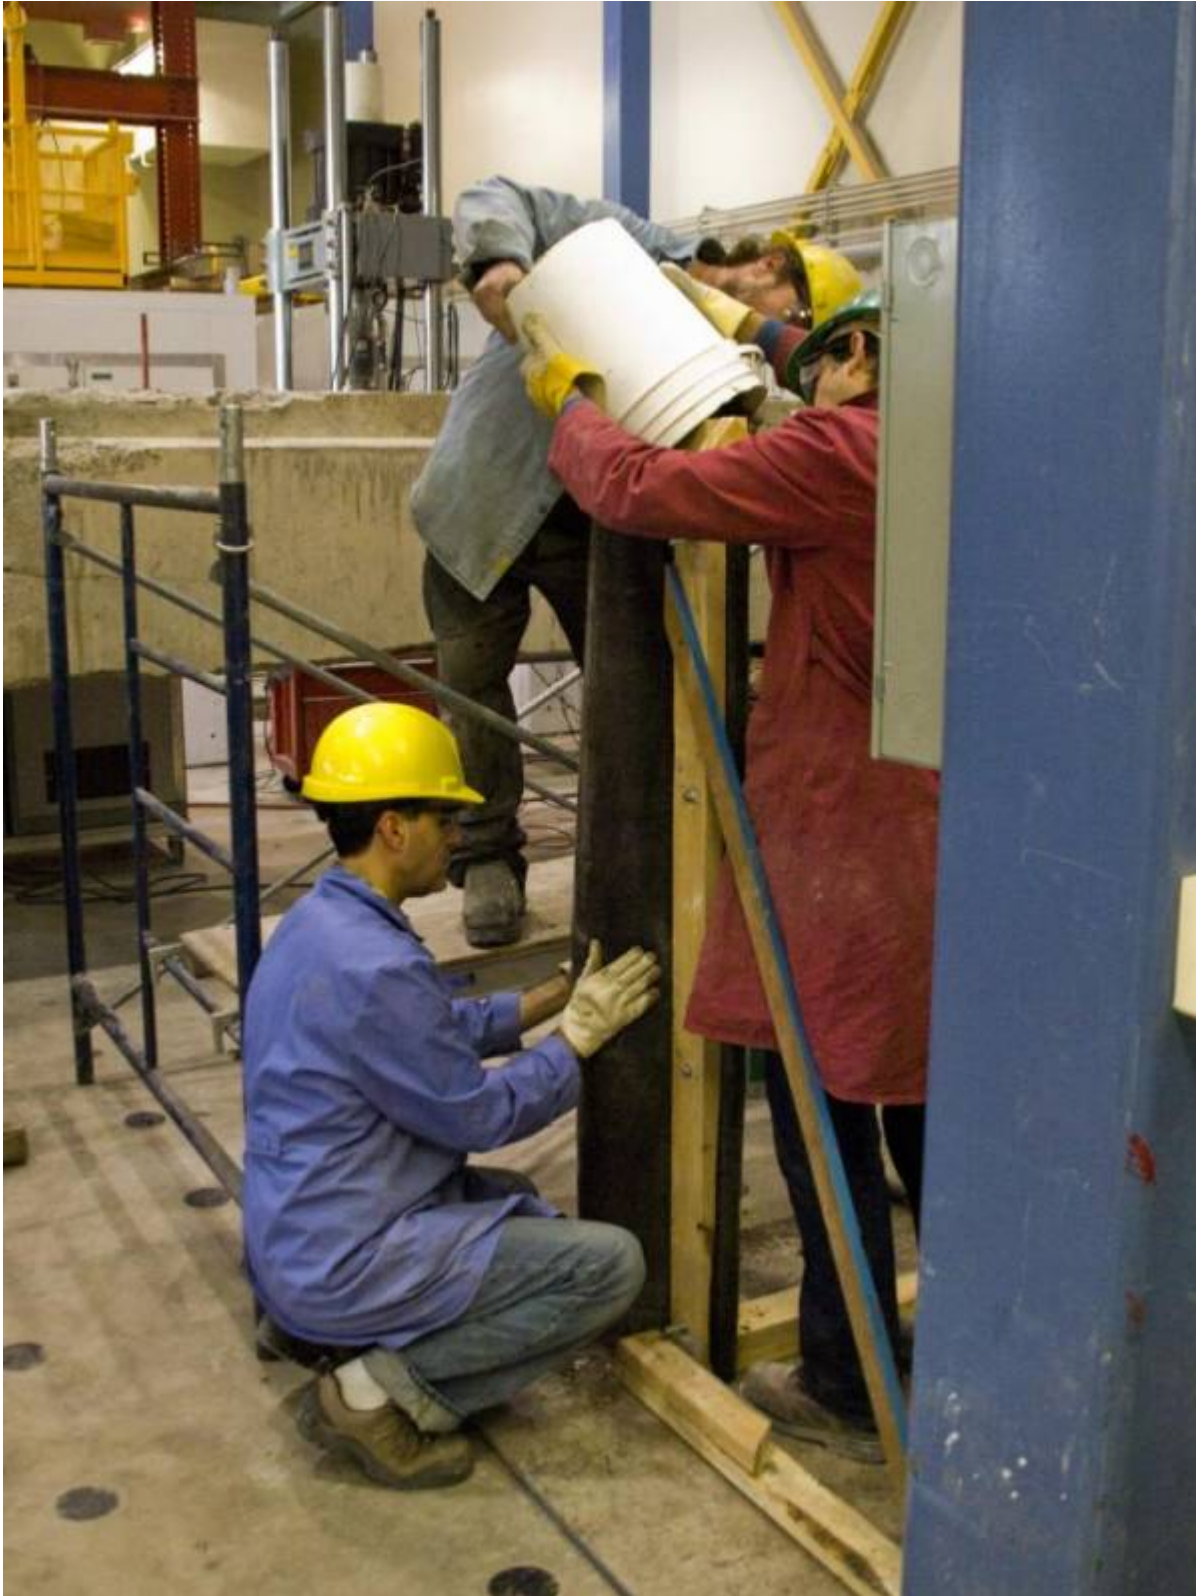
Figure 47: casting of column in fabric formwork.

When the concrete was delivered, the slump value was measured and fifteen 101 by 203 mm (4 by 8 in.) PVC control compressive strength test specimens were cast. Fresh concrete was transferred by hand directly from the truck mixer's discharge chute to buckets and then into the forms as demonstrated in Figure 47. Each specimen was vibrated both inside and outside, using a portable electric internal vibrator at 5 to 15 second intervals. In case of fabric formwork, hand tapping the mold wall was also used to vibrate the concrete and help the bleeding of the air bubbles and extra water from the concrete. All columns and companion cylinders were cured in the same manner. Forms were stripped after one day, after which the columns, as well as the control samples were cured for another 3 days using wet burlap and plastic sheets as vapour barrier cover. Unlike in the cardboard formed columns, no sign of color variation was observed in fabric formed columns. No imperfections such as bug holes or the appearance of large aggregates were seen on the fabric-formed concrete surface. Such column could be easily used as exposed concrete structural members with no necessity for expensive patch ups, epoxy coatings or paintings or architectural veneers.

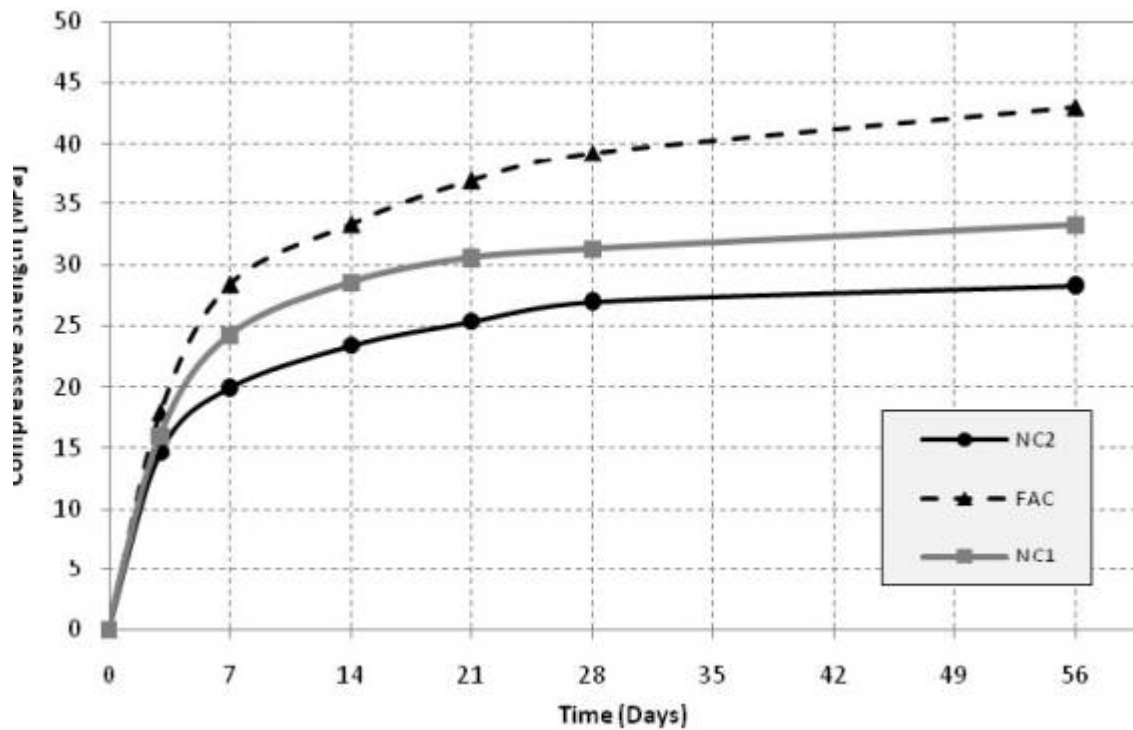
Figure 49: Concrete strength gain with time.

A compression testing machine was used to test the companion 101 by 203 mm (4 by 8 in.) concrete cylinders at the ages of 3, 7, 14, 28 and 56 days. All cured columns and the concrete cylinders were taken out of their molds simultaneously and were kept in the laboratory till testing. Figure 49 provides the data concluded from the cylinder compression tests. Both batches were specified to reach compressive strength of 25 MPa at 28 days but as the results show, the flyash concrete gained more compressive strength compared to the normal concrete. As seen in Figure 49, average compressive strength of the flyash sample at 28 days was measured as 39.2 MPa while the normal concrete specimens had average compression strength of 27 and 28.30 MPa. The actual compressive strength in both concretes was used to estimate the actual maximum axial load capacity of the columns.

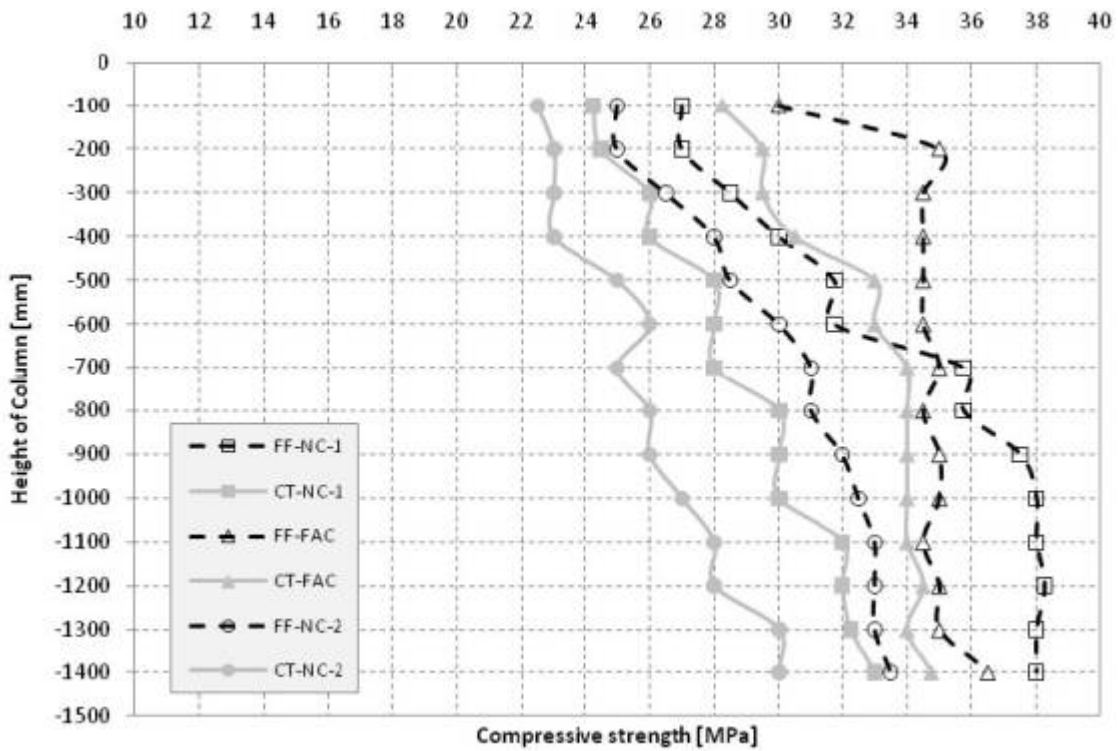
Figure 50: Results from the Rebound tests showing the variation of strength...

Instructions for preparation of the concrete surface were carefully followed before and during the use of the hammer. Each assigned point was tested for 8 impact readings. Following the manufacturer's manual, the impact points were spaced at least 20 mm apart. The mean value of the 8 rebound values (R) was then calculated. Conversion curves were used to find the corresponding compressive strength of the average R values. For comparison purposes, only 28 day readings are provided in Figure 50. Charts showing the change in compressive strength along the height of the column for all columns have been provided in [Appendix C](#).

As seen in the chart, all columns formed with fabric showed more surface strength than those formed with cardboard. When normal concrete is used, the difference between the compressive strength of the specimens cast in cardboard versus fabric formwork at the bottom of the column is between 12 and 15%. The difference between the formworks when using flyash concrete has minimal significance (5% difference). This is an indication of flyash particles possibly clogging fabric pores and therefore, reducing the amount of water bleeding and eventually resulting in less increase in compressive strength. In

addition, regardless of the formwork type and referring to the results obtained from Schmidt hammer tests, the top end of the columns always proved to be weaker than other sections of the column. A phenomenon that appeared in both cardboard and fabric formed columns due to less compaction and less concrete density at top end of each column.

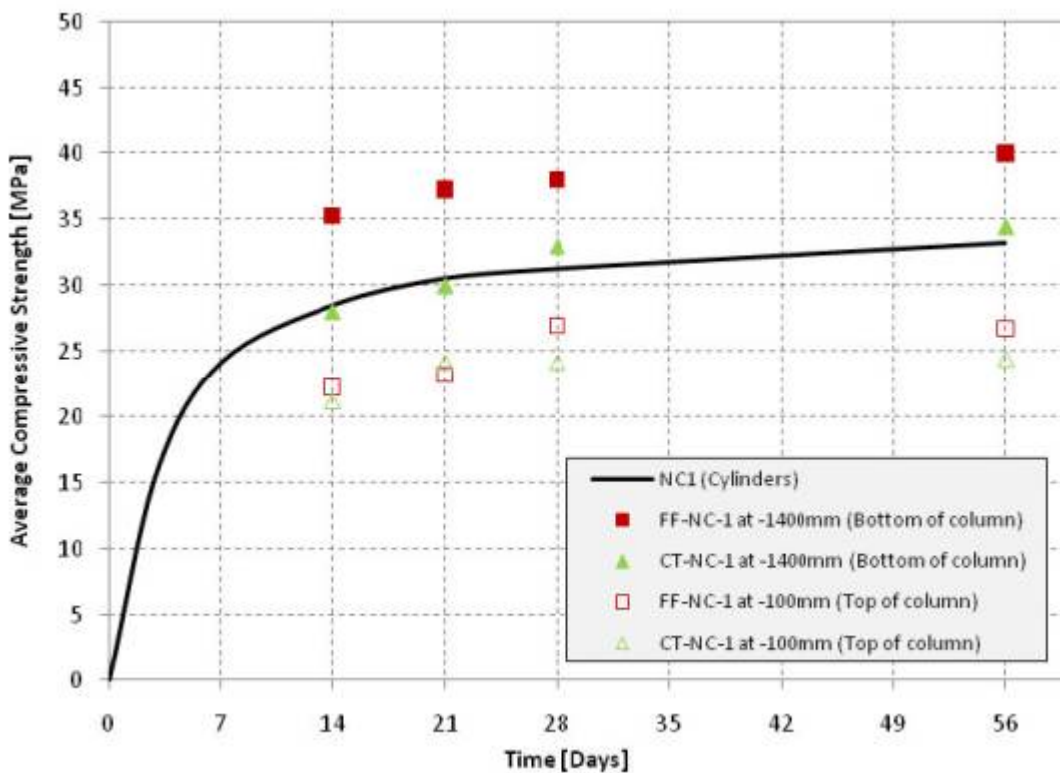
Figure 51: Normal concrete cylinders compared to Schmidt hammer results (Columns...)

Compression strength test results from Schmidt hammer test have been compared to those from cylinder test for both normal and flyash concrete. As seen in Figures 51, 52 and 53, there are some fluctuations between the results obtained from Schmidt hammer and the PVC formed cylinders. The filled markers in the graph represent the bottom of the column, while the empty ones represent the top of the column.

As seen in Figure 51, compared to results from cylinder tests fabric formed column has gained an average of 21.8% extra strength at the bottom of the column while the bottom of the cardboard formed column shows almost the same results as the cylinders. At the top of the column, both cardboard and fabric formed columns showed an average of 28% less strength compared to the cylinder test results. As seen in Figure 52, cylinder test results for flyash concrete show more compressive strength than both top and bottom readings of the Schmidt hammer.

It is clear from the comparisons that for normal concrete the strength data from Schmidt hammer and from the cylinder test is comparable. Schmidt hammer is usually used to evaluate concrete strength of existing structures and it was shown in the previous figures that the strength is evaluated accurately. The method seems to be less accurate for the flyash concrete.

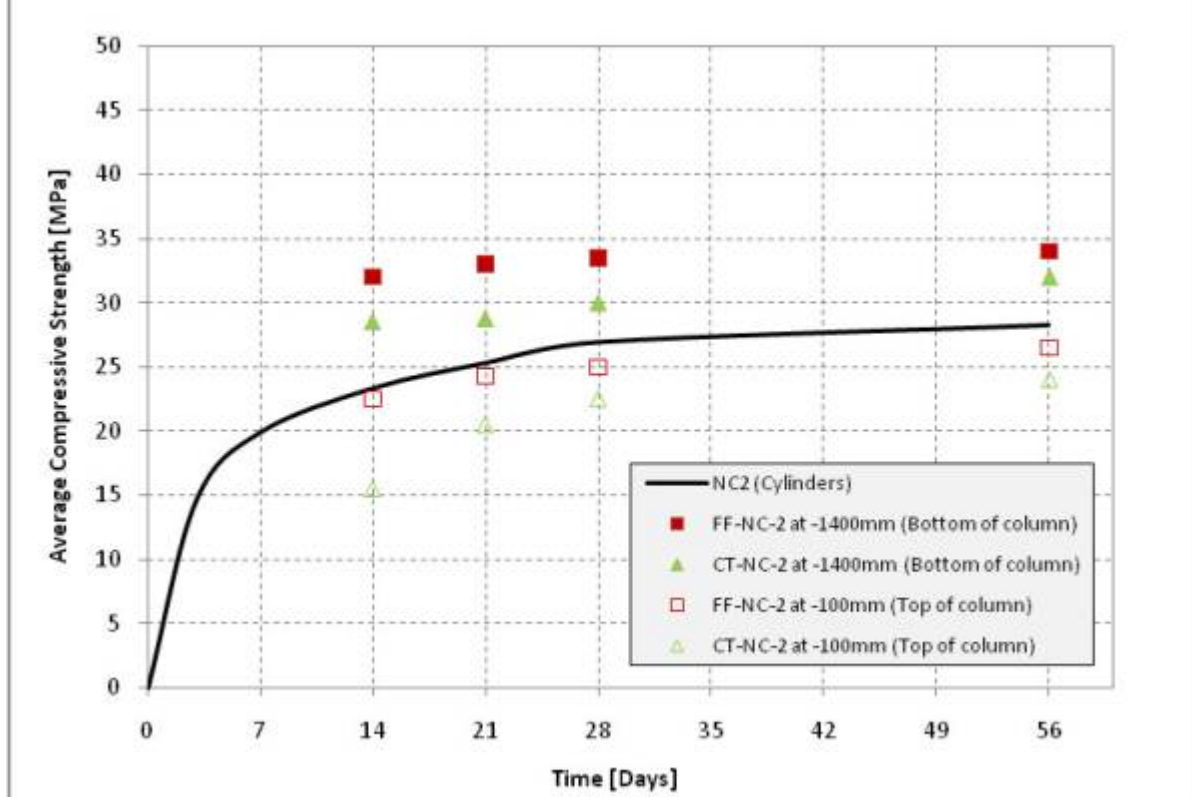
Figure 53: Normal concrete cylinders compared to Schmidt hammer results (Columns...

The difference between the readings of the Schmidt hammer at different ages stays constant but for some reason does not follow the strength indicated from cylinder tests. For the second set of normal concrete columns and cylinders, it can be seen in Figure 53 that compared to results from cylinder tests, fabric formed column has gained an average of 28% extra strength at the bottom of the column while cardboard formed column shows 14% difference. Schmidt hammer reading from the top of the columns shows 15% less compressive strength for cardboard formed columns and 6% less for fabric formed columns.

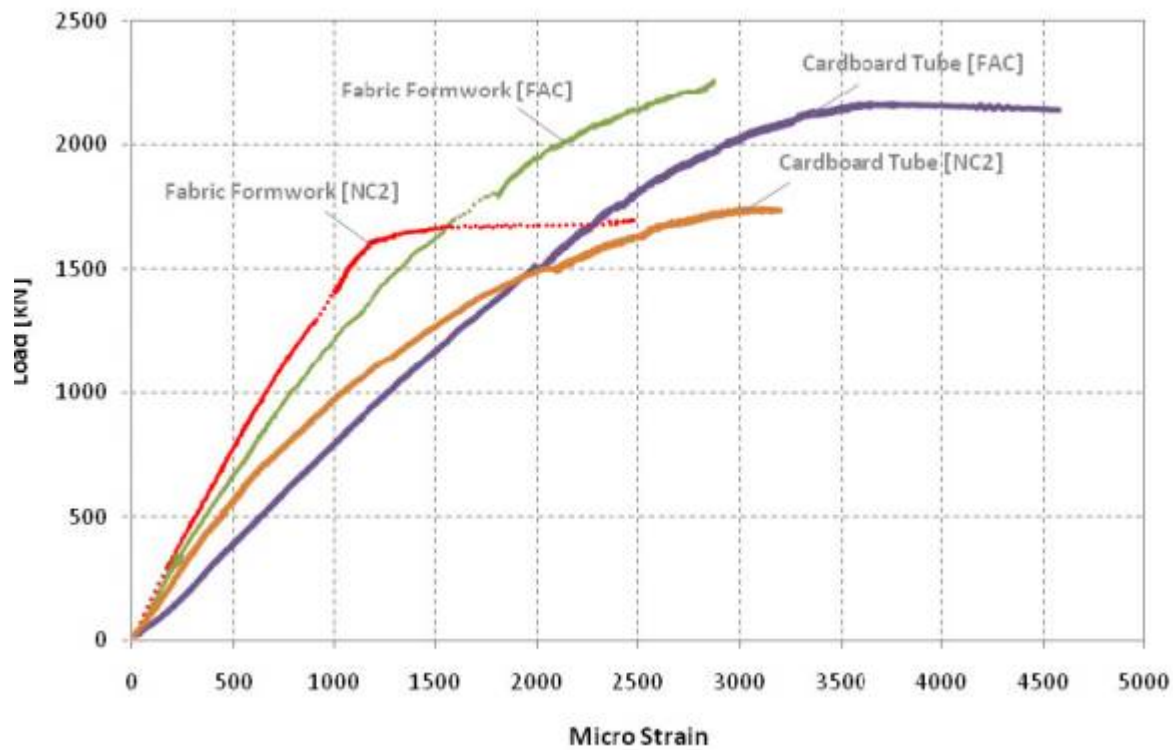
Figure 55: Maximum axial load of fabric-formed versus cardboard-formed steel...

Compressive strength as given by the control cylinder tests at the age of 56 days was used to recalculate the theoretical expected maximum axial load of the steel reinforced column specimens. Table 8 provides a summary of the specifications of the tested columns and the obtained results. It can be noted that the formwork type had no bearing on the strength of either the normal or flyash concrete columns.

As seen in Table 8, the first two columns (FF-NC-1 and CT-NC-1), normal concrete columns formed with fabric and cardboard, withstood 1850 kN and 2200 kN of axial load, respectively. Maximum axial load of flyash specimen (FF-FAC and CT-FAC) was 2271 kN for fabric formed column and 2165 kN for cardboard formed column. As shown in Figure 55, for the last two columns (FF-NC-2 and CT-NC-2), normal concrete columns formed with fabric and cardboard carried 1703 kN and 1744 kN of axial load, respectively.

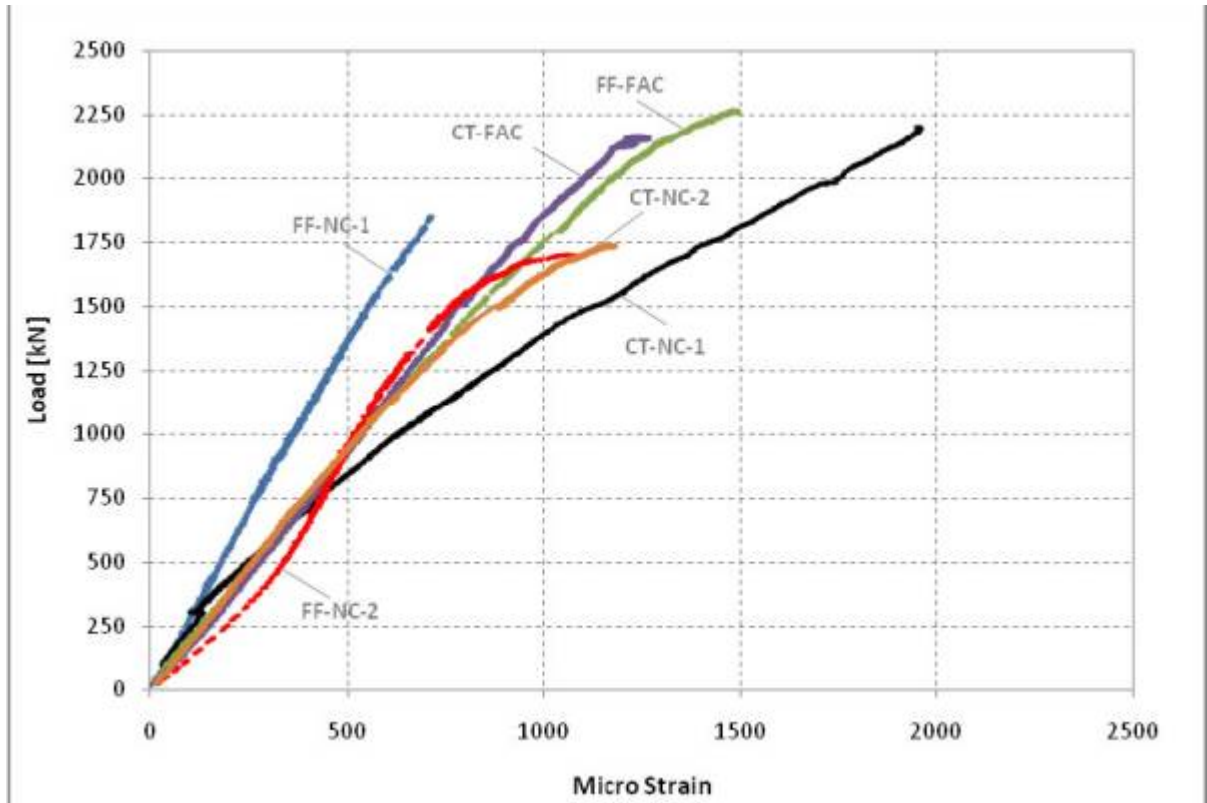
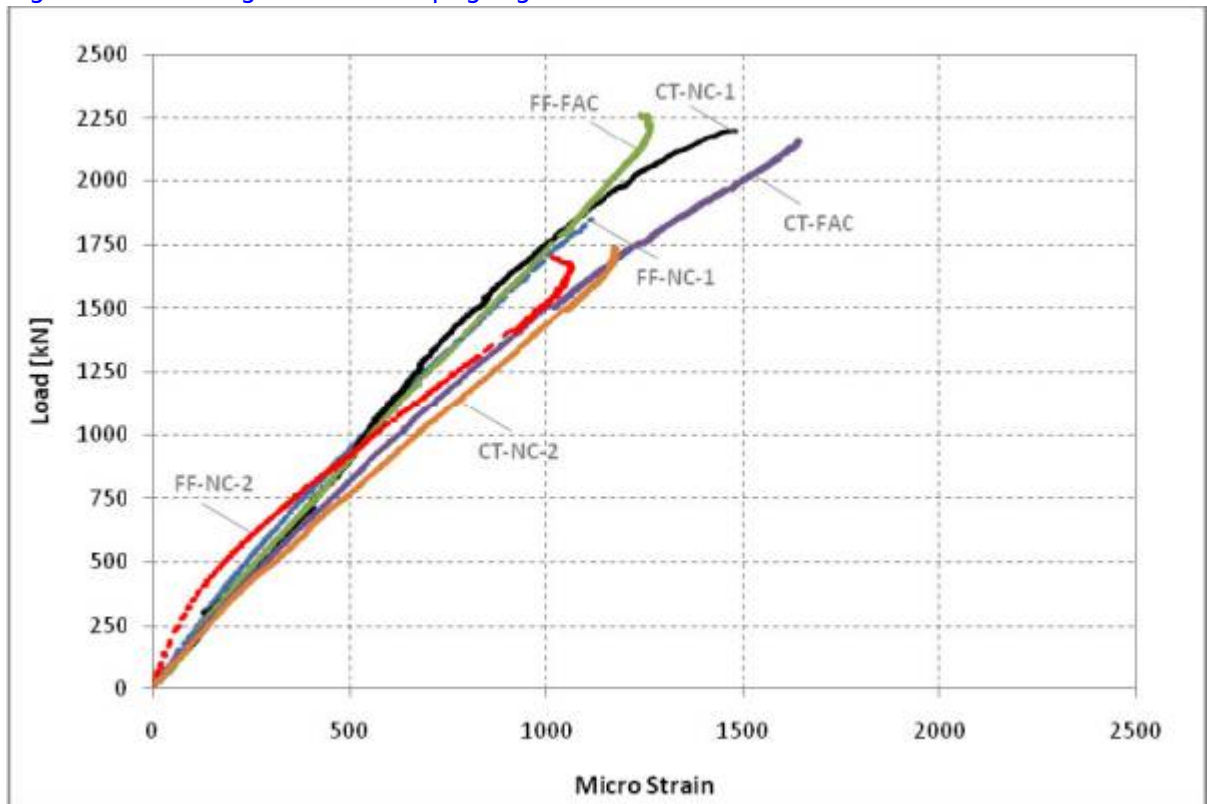
Figure 56 to 59 depict the strains in the middle, while Figures 60 to 63 depict the strains at the top of the column. Each figure represents one location either North, South, East or West and strains of that location in each column were plotted in the same graph for comparison.

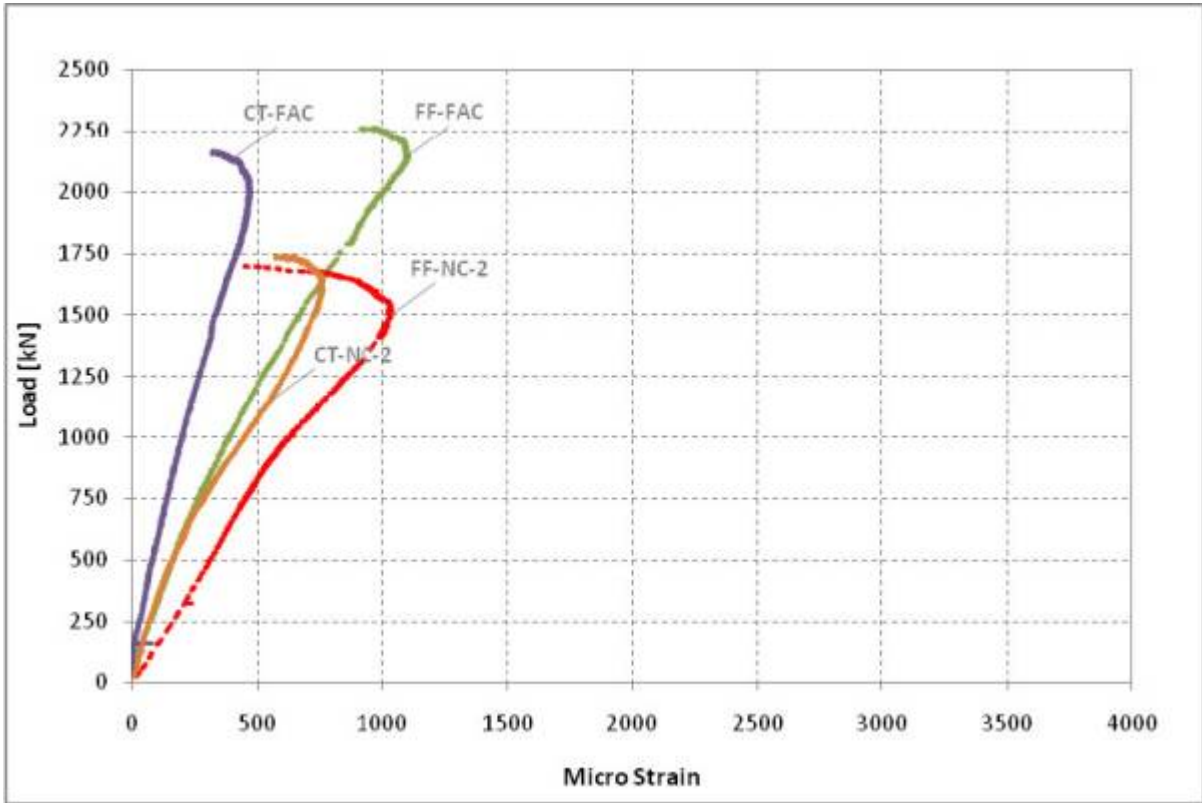
Figure 60: Readings from North pi-gauges at the top of all columns.

As seen in Figure 60 which represents the readings from North pi-gauges at the top of all columns, a trend of reverse strain close to the failure load is observed. This means that as columns were starting to crush at another location, the surrounding concrete was experiencing some tension. Figure 61 represents readings from South pi-gauges at the top of all columns. As seen in this figure, columns undergo much

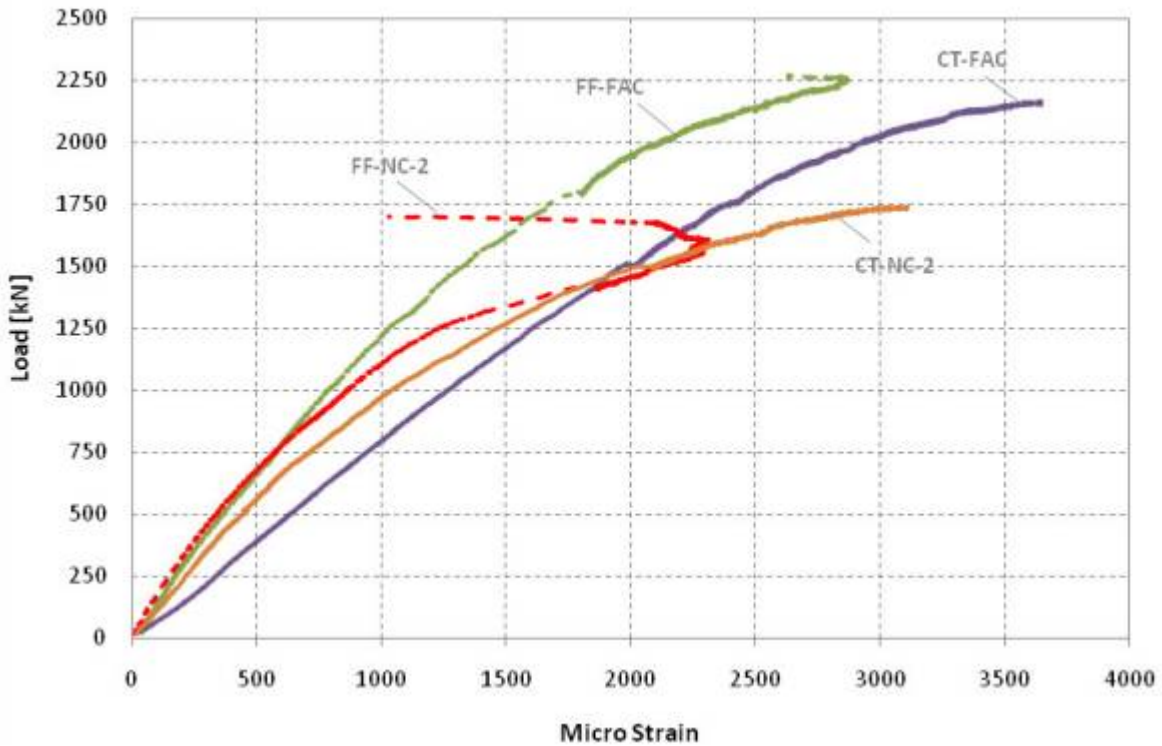
Figure 61: Readings from South pi-gauges at the top of all columns.

larger strain values as high as 3600 micro strain at the load of about 2150 kN in case of column CT-FAC. Strain values read from the south pi-gauge of column FF-NC-2 change direction from compression to tension close to the failure load. This has been caused by the uneven failure of the column at top. As seen in Figure 64, the opposite side of the column across from the south pi-gauge has failed in compression and caused some tension in south-top-zone of the column. Figure 62 which represents the readings from West pi-gauges at the top of all columns shows the highest strain in column CT-NC-2 as 3000 micro strain at the corresponding load of 1750 kN. A similar trend is observed in Figure 63 from the values taken from top-East pi-gauges. Column FF-FAC carries 2700 micro strain at the load of 2250 kN. As seen in all top pi-gauge curves, except column CT-NC-2, regardless of the form-work type, flyash concrete experienced more strain than normal concrete. As seen in Figure 65, all six columns failed at the top. This type of failure in columns has been documented before in research conducted by Bazant and Kwon [2] which found that regardless of the cross sectional size of the column, the fracture mechanism stayed the same. The reason for the top end failure is that the top end of a vertically cast member will always have less compressive strength than the lower parts of the member, due to increased pressure and compaction towards the bottom of the mold [3]. This holds true regardless of the formwork used.

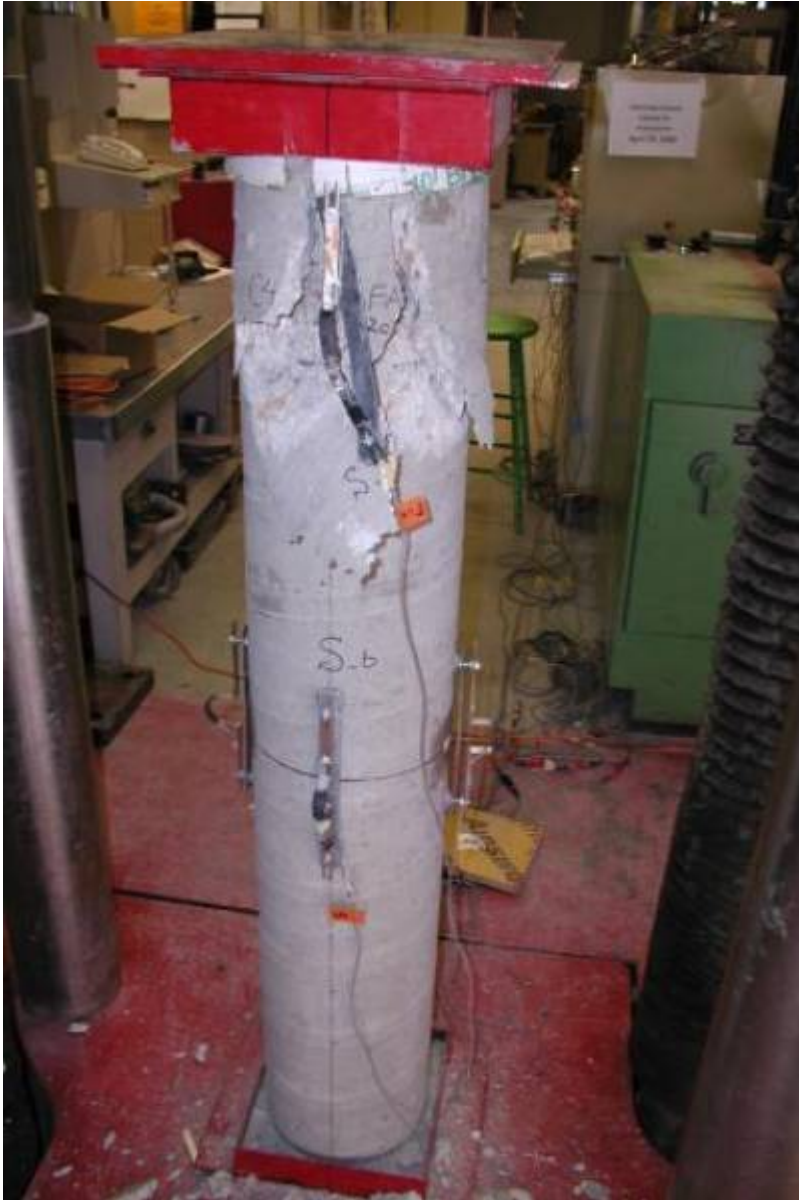
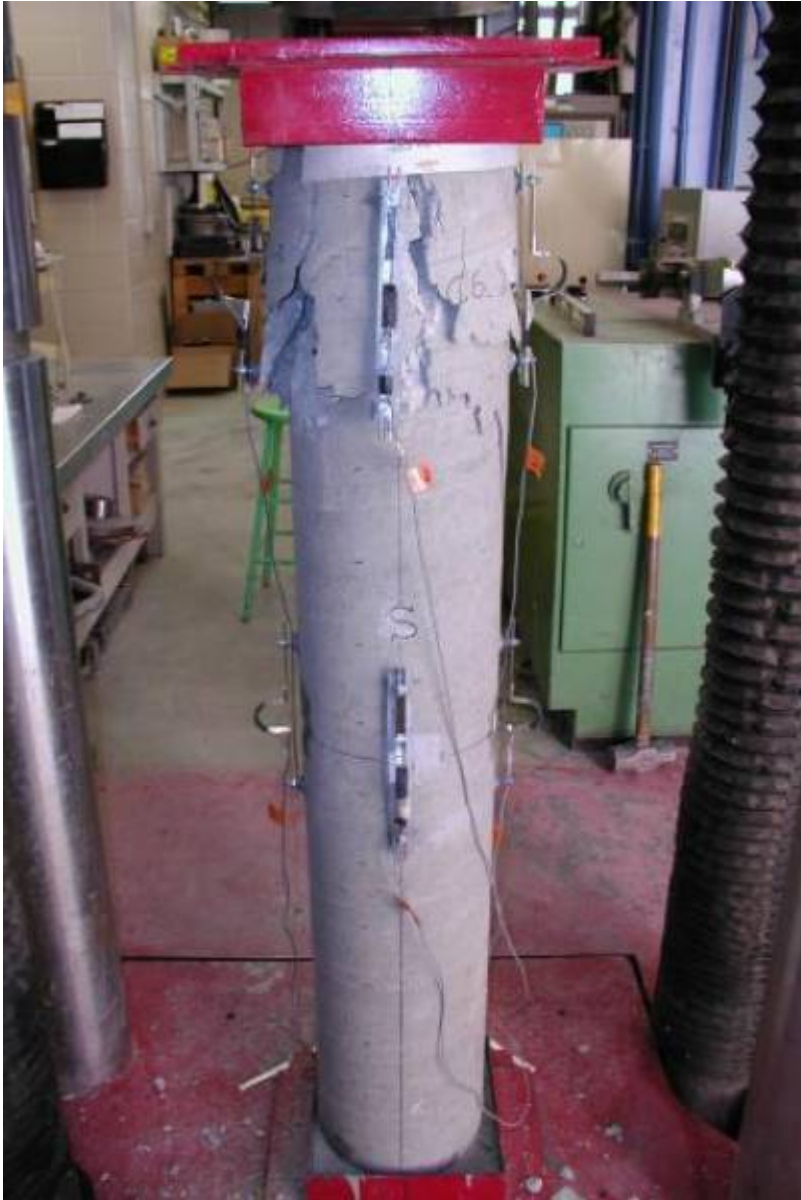
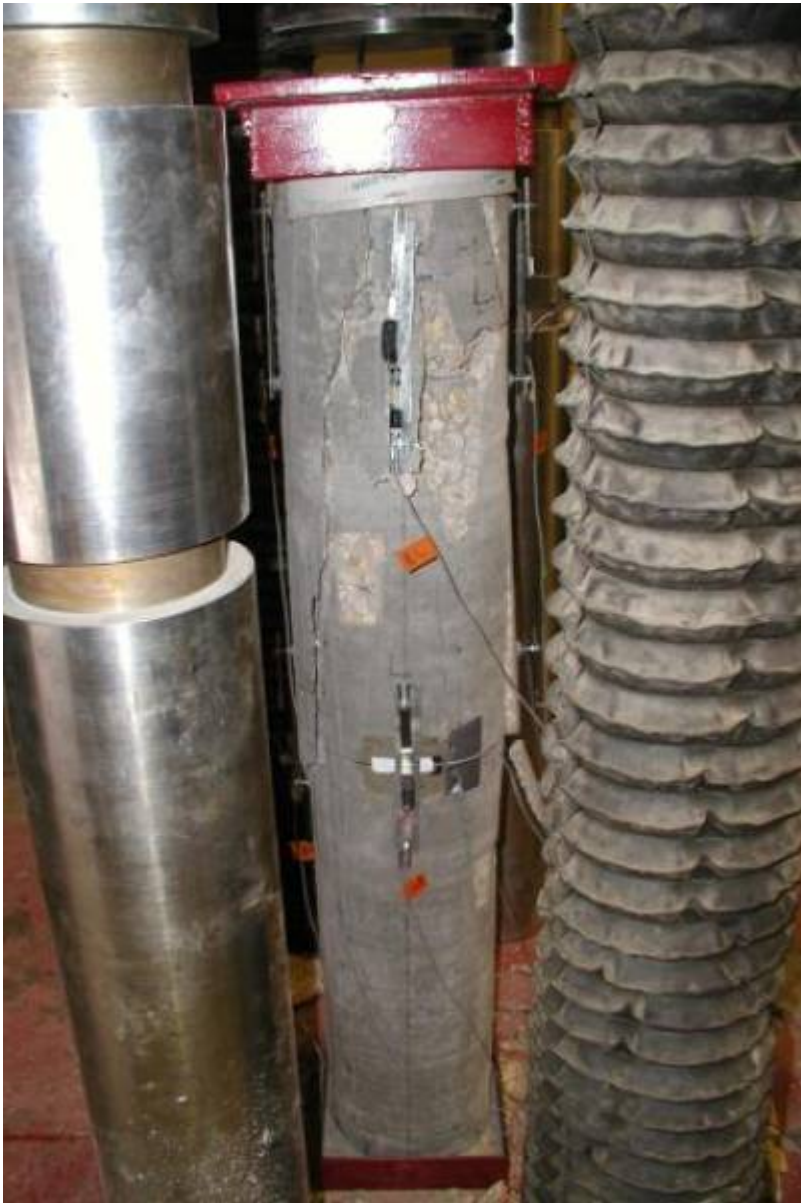
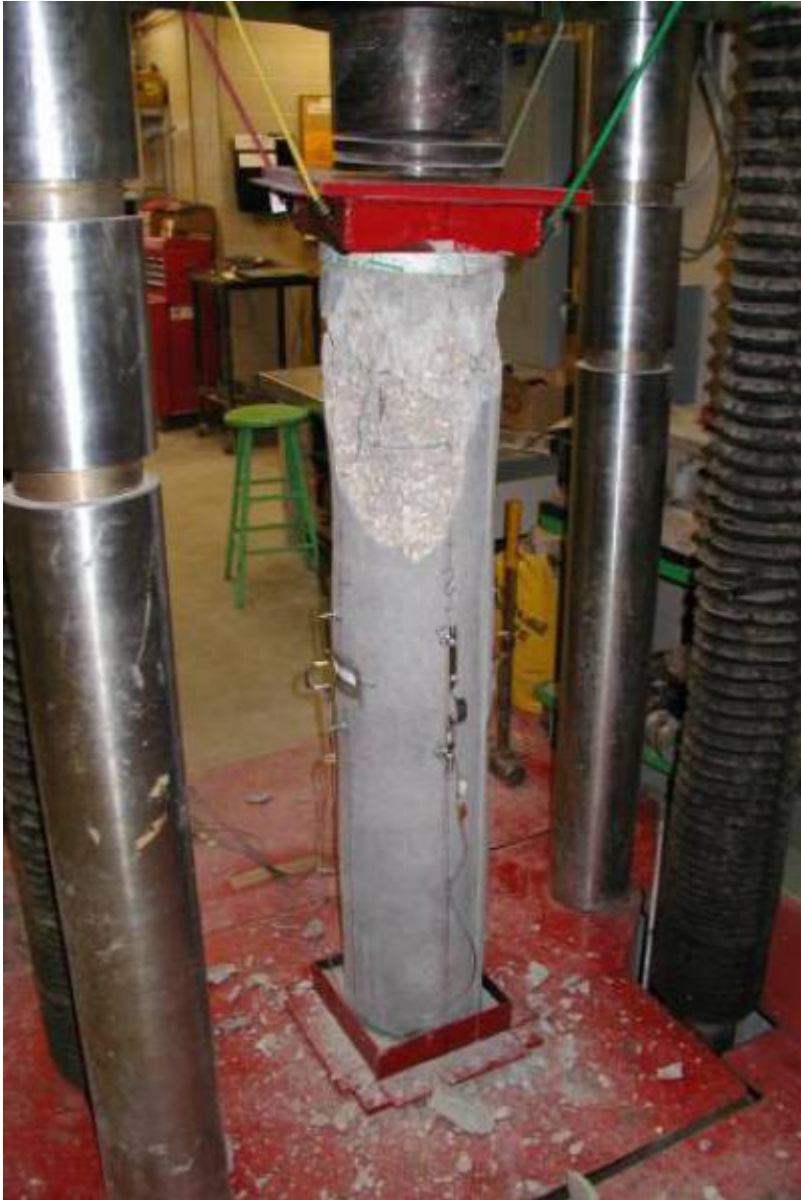
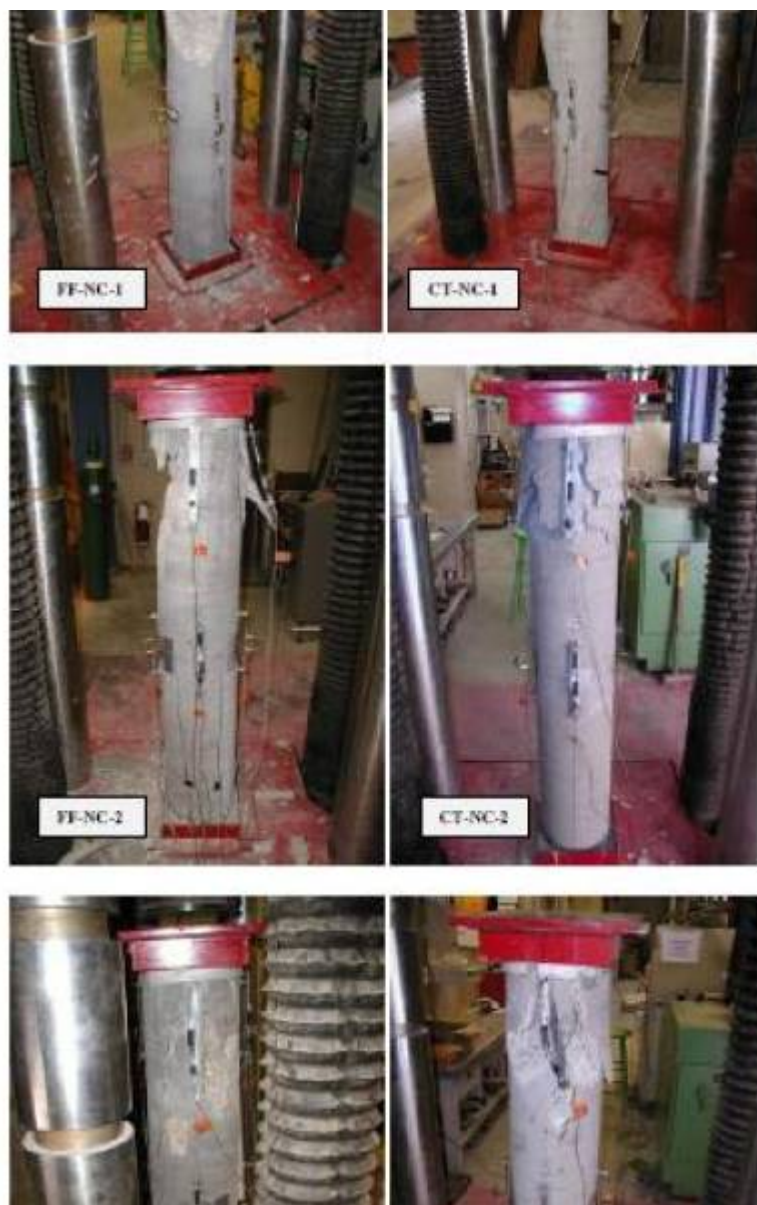
In order to be able to better observe behavior and the failure pattern of the columns, all tests were videotaped. The failure pattern of the columns was a factor to be investigated in this phase of the study. Based on observations of the two cardboard and two fabric-formed column tested, the failure of the cardboard formed column started with crushing on top and then spalling till failure. Cardboard-formed columns presented a typical gradual failure with no sign of brittleness, no longitudinal cracks and no flaking. On the other hand, fabric-formed columns started with crushing on top and development of longitudinal cracks at the same time along with spalling. Also, some flaking and relative sudden failure of

outside surface was observed. Photographs of these column failures are shown in Figure 65 (page 82).

Flaking and surface concrete delamination observed in the failure of both fabric-formed columns also confirms that the surface of the concrete cast in fabric formwork was more brittle than concrete cast in conventional formwork. The change in Poisson's ratio was also studied when these columns were tested. The value was derived from dividing the average value of the data from two circumferential strain gauges placed at 180° apart from one another, by their corresponding axial pi-gauges. Both flyash and normal concrete fabric formed columns, proved to have lower Poisson's ratio value which is another indication of brittleness and less surface deformation in the fabric-formed specimens. It is necessary to mention that it is nearly impossible to form a perfectly straight column using handmade fabric column formwork, so very small values of eccentricity in loading condition may occur. Since small values of the eccentricity do not create large moment values at end portion of the columns, the effects of small eccentricities can be neglected [2].
