## Appendix C: Results from Rebound Tests (Schmidt Hammer Tests)

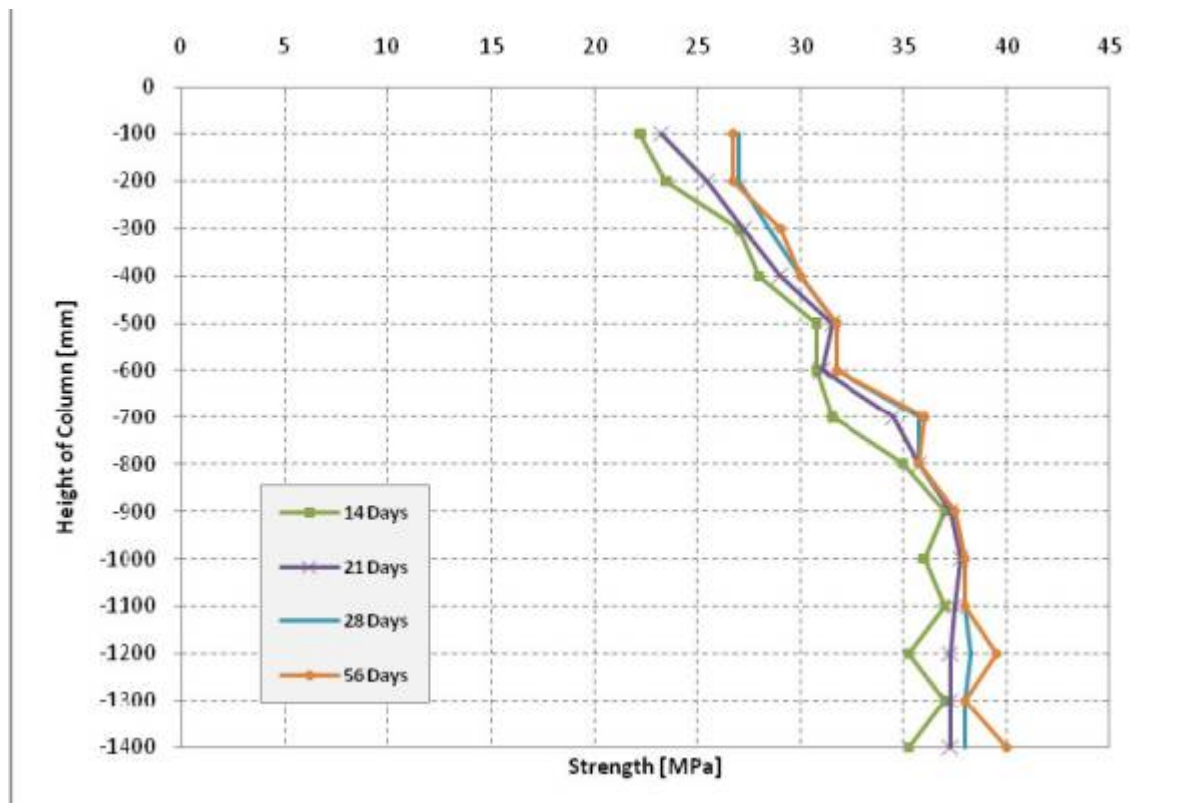
Figure C1: Column C1 – Fabric Formwork, Normal Concrete.

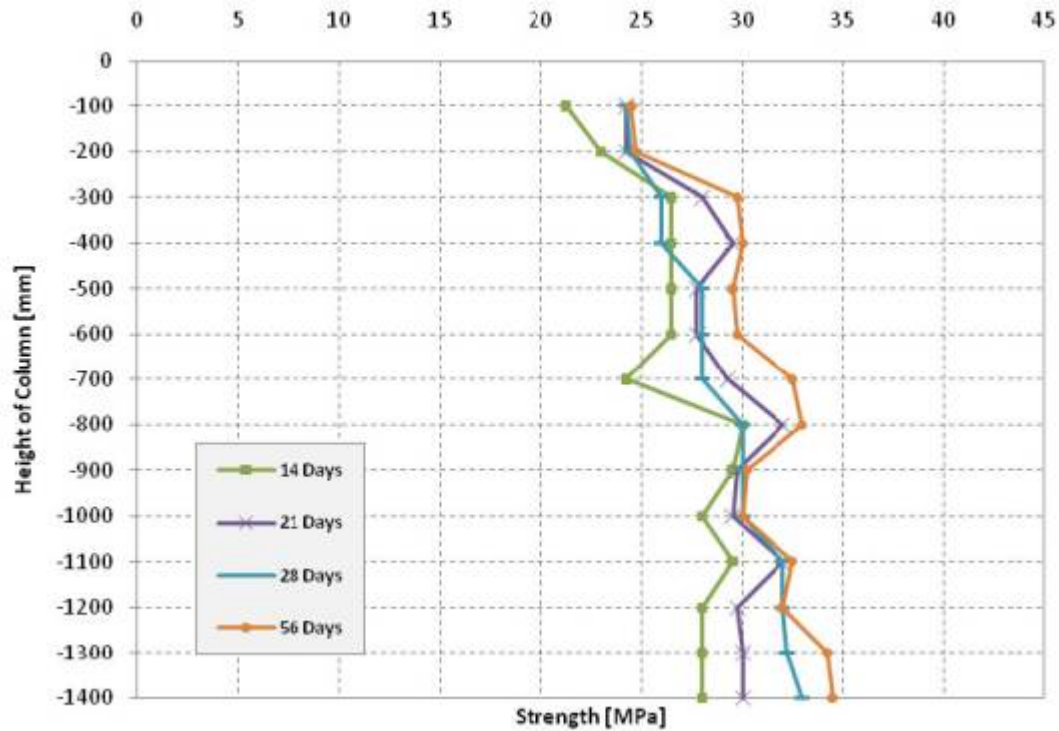
Figure C2: Column C2 – Cardboard Tube, Normal Concrete.

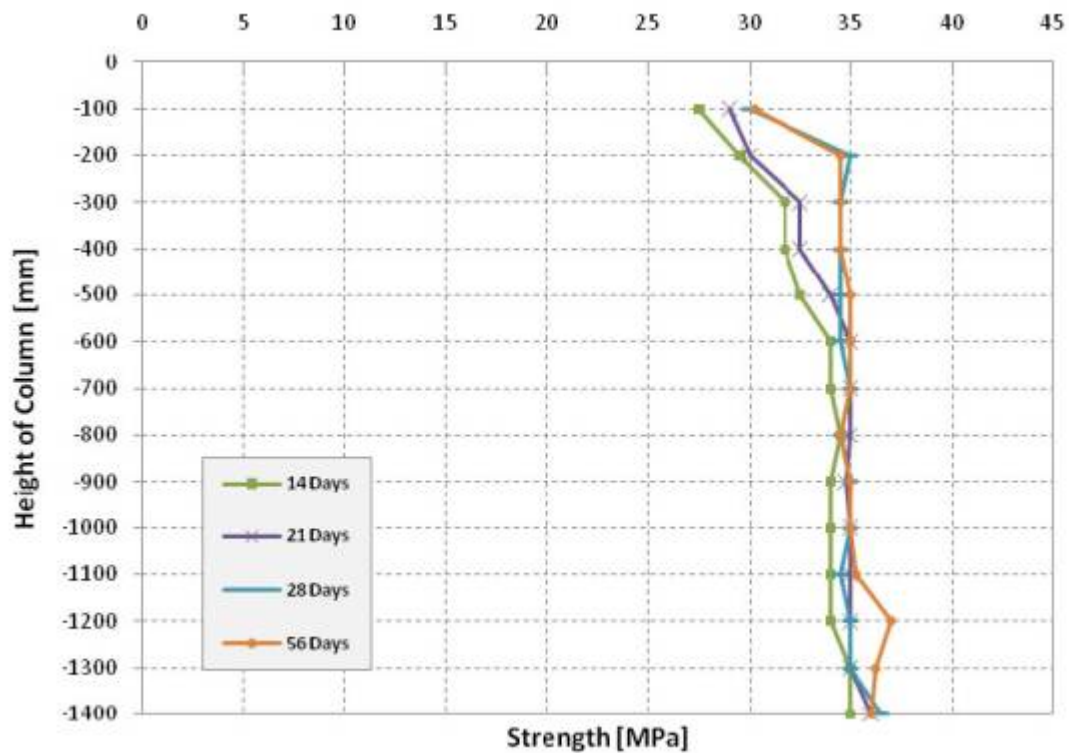
Figure C3: Column C3 – Fabric Formwork, Flyash Concrete.

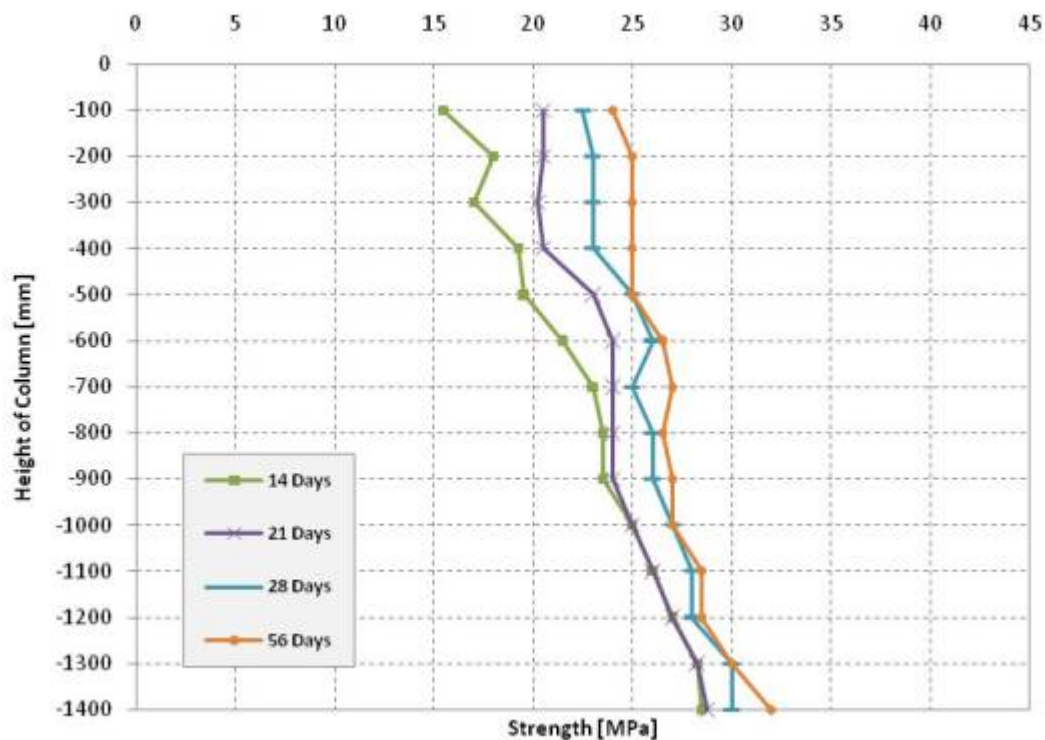
Figure C6: Column C6 – Cardboard Tube, Normal Concrete.
