# **Strength Tests**

Concrete cylinders were cast in the two fabric types and in watertight PVC molds, and tested for compression strength at the ages of 3, 7, 14 and 28 days. The difference in overall strength between fabric-formed cylinders and PVC cast cylinders was then used to gauge the effects of formwork on the strength of concrete.

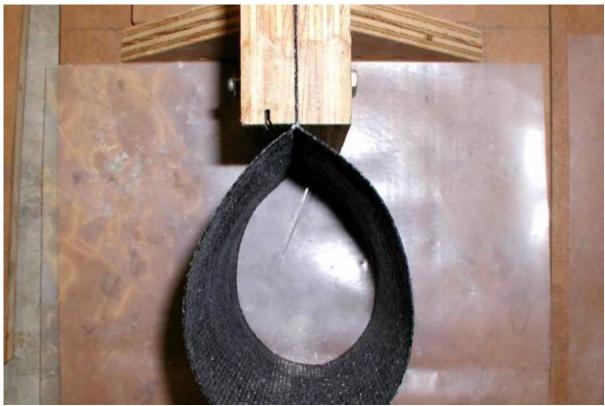
Figure 33: Fabric formwork shown from above.

Both fabric-formed and PVC formed control cylinders were cast in a vertical position (Figure 33) and compacted using the standard placement and vibration procedures [1]. The bottom of each fabric formed cylinder was protected by a plastic sheet in order to prevent water absorption from the wood base, simulating the same condition as in the PVC molds (Figure 34). All PVC and fabric-formed specimens were cast using the same batch of fresh concrete made on premises. The same mix designs were adopted as in earlier tests [Table 2 and Table 3], (Chapter 2, Table 1 and Table 4). Aggregates were washed thoroughly and precise scaling was employed when weighing the aggregates. A 100 litre pan concrete mixer was used to mix the fresh concrete.

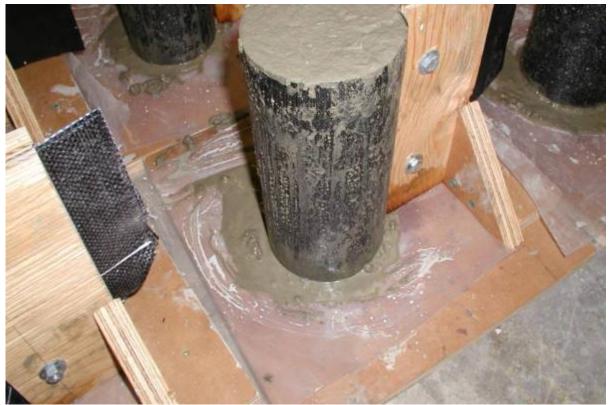
Figure 34: Fabric-formed concrete cylinders.

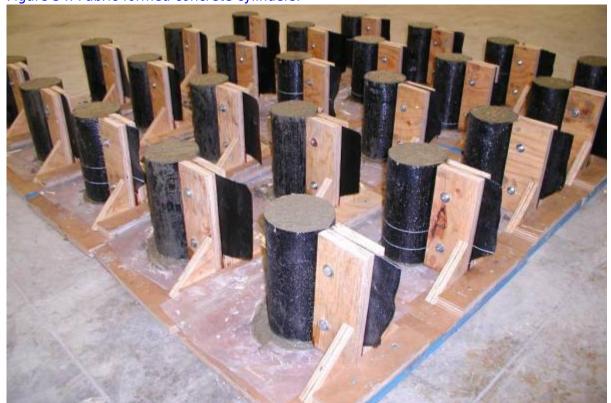
Figure 35: Fabric-formed cylinders after casting.

When the concrete was ready it was brought to the molds by wheel barrow for casting. Cylinders right after casting are shown in Figure 35. When casting the normal concrete, ambient temperature of the laboratory was recorded as 22 degree Celsius and the slump of the fresh concrete measured as 90 mm. For the flyash concrete, the temperature was recorded as 24 degree Celsius and the slump value was measured as 85 mm.

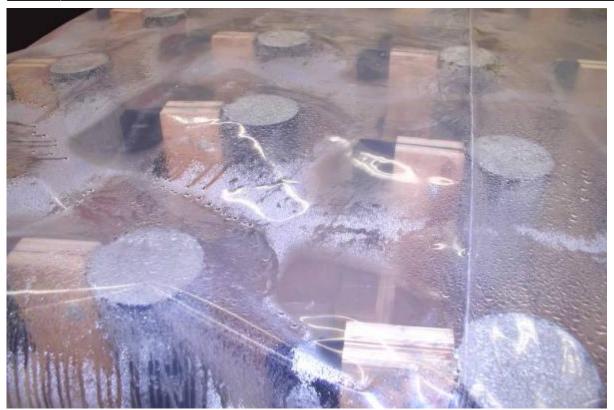
Figure 36: Cylinders curing.

Two hours after casting, all specimens were covered with plastic sheets (Figure 36) and left in place for 24 hours. Sandwich boards, bolts and fabric forms were carefully taken off the fabric formed specimens after the first day. PVC cast hardened concrete cylinders were removed from the PVC molds after one day using air pressure. All specimens were then transferred to a curing room in order to maintain uniform curing conditions before testing. The temperature of the curing room was recorded as 20 degree Celsius and relative humidity as 100 percent.

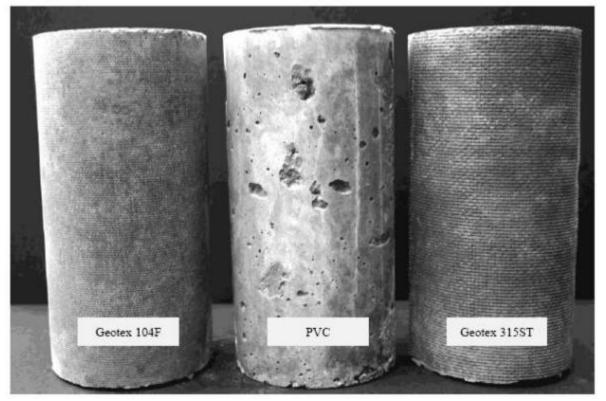
Figure 37: The effect of mold on quality of quality of concrete finish.

When visually inspected, the surface of the specimens formed with fabric had a finely textured surface imprint. Unlike PVC formed samples, no large aggregate or bug holes were visible on the concrete

surface. Figure 37 shows three cylinders cast from left to right, Geotex 104F, PVC and Geotex 315ST.

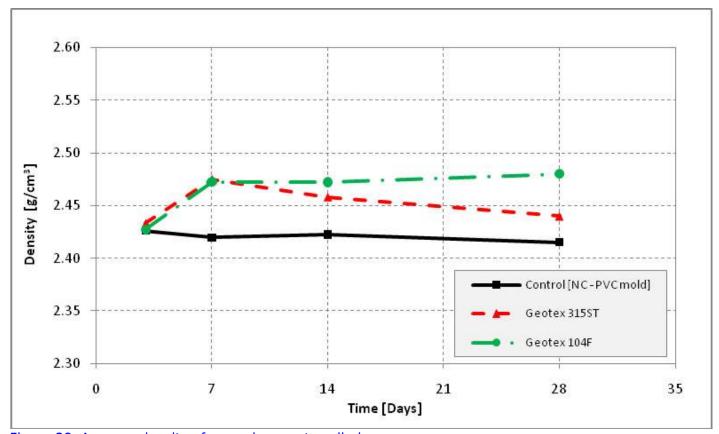
Figure 38: Average density of normal concrete cylinders.

Samples were tested at 3, 7, 14 and 28 days using a compression testing machine at the University of Manitoba structures laboratory. Strength gains of fabric formed cylinders were compared to PVC formed cylinders. The densities of all cylinders were determined before testing in order to study the relationship between type of mold and the effect on density and strength of the hardened concrete. As seen in Figure 38 and Figure 39, regardless of type of concrete, fabric formed cylinders gained higher densities. When normal concrete was used, Geotex 104F gained higher density while Geotex 315ST shows higher density when flyash concrete is used. Compared to PVC-formed companion control samples, fabric-formed concrete cylinders showed an average of 2 percent higher overall density when normal concrete was used and 3.3 percent higher density when flyash concrete was used. This might be due to air and water loss through the porous mold wall. Studies suggest that increase in density of concrete can result in increase in compressive strength of concrete [2].

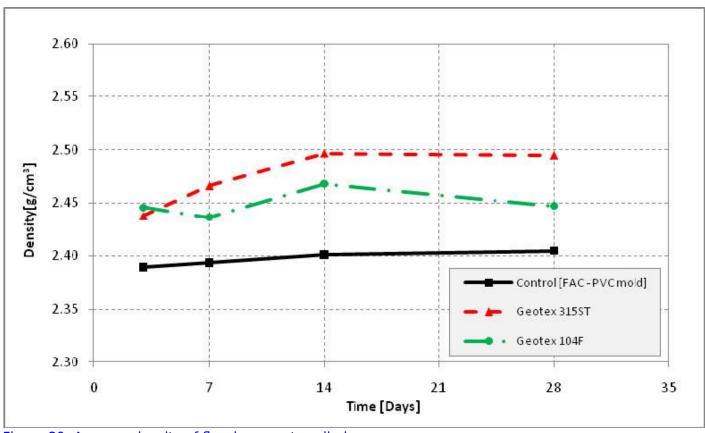
Figure 39: Average density of flyash concrete cylinders.

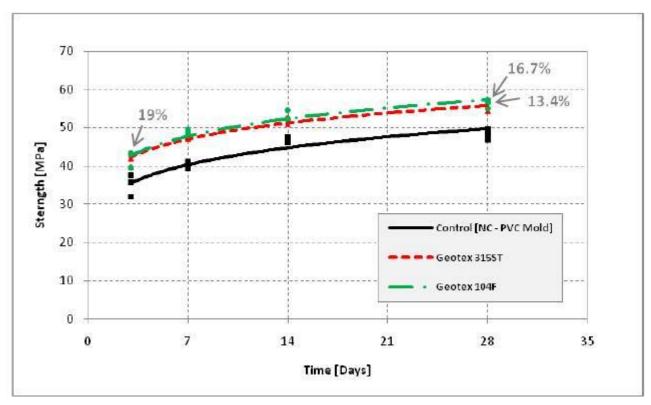
Figure 40: Strength gain of normal concrete.

Figures 40 and 41 show strength for normal and flyash concrete respectively. The fabric formed normal concrete had about 19% higher strength at three days for both fabrics compared to PVC mold. After 28 days, Geotex 315ST cast normal concrete gained 13.4% of strength, while Geotex 104F gained 16.7% of strength. This can be clearly seen in Figure 40.

In both normal and flyash concrete the difference between strength increase due to fabric formwork remained almost the same. Comparison of concrete strength gain between the two fabric used revealed only 3% difference. Considering the fact that the two fabrics that were chosen represented a wide range of pore sizes in available woven geotextiles, it can be suggested that within limits, the final strength of a fabric formed cylinder may not be dramatically affected by the type of fabric used.

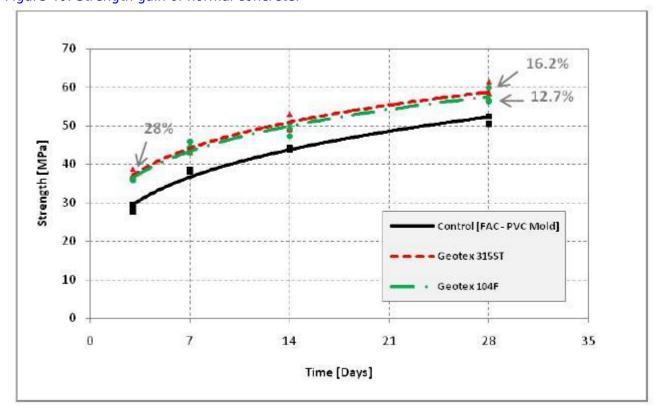
Figure 41: Strength gain of flyash concrete.

As seen in Figure 41, the fabric formed flyash concrete had a 28% higher strength at three days for both fabrics compared to PVC mold. After 28 days, samples formed with Geotex 315ST gained 16.2% extra strength compared to the control PVC samples, while Geotex 104F gained 12.7% of strength. Flyash samples gained higher overall strength compared to normal concrete.
