The Evaluation of Changes in Concrete Properties Due to Fabric Formwork

A thesis submitted to the Faculty of Graduate Studies of
The University of Manitoba
in partial fulfilment of the requirements for the degree of

Department of Civil Engineering
University of Manitoba
Winnipeg

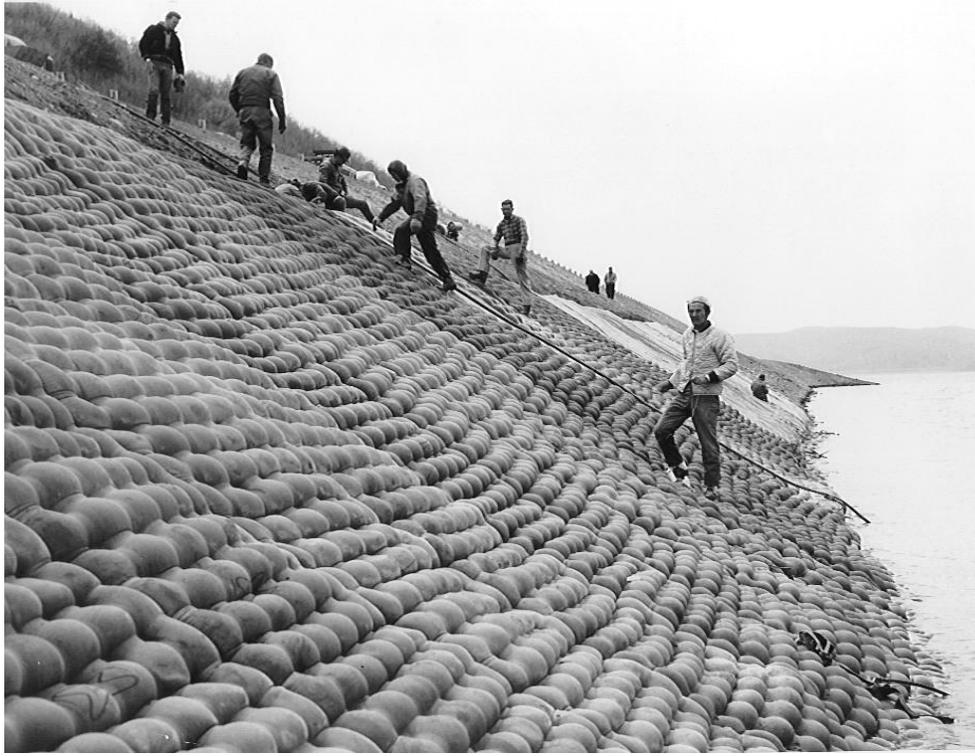
Figure 5: River bank stabilization bags (Fabriform) installed in 1967 on the Allegheny Reservoir, New York (www.fabriform1.com 2009)

Further practical applications occurred in the mid 1960's with the introduction of fabric formwork for erosion control and pond liners (Figure 5). The efforts of E.W. Bindhoff (1982), B.A. Lamberton (1989), and others led to the first sustained commercial applications of fabric formworks.

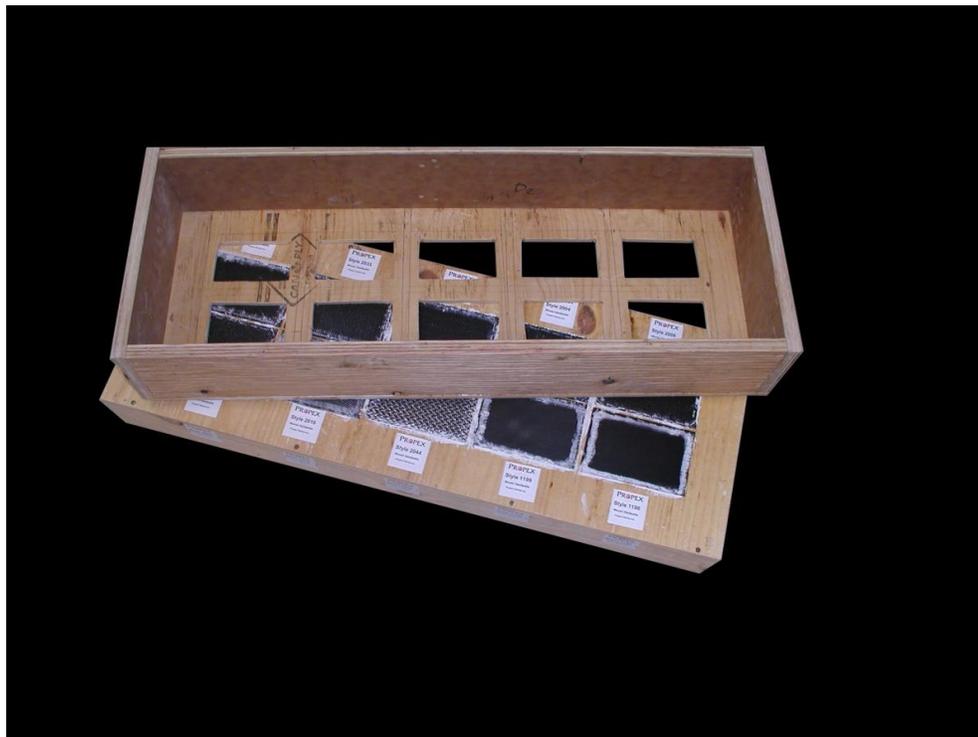
Figure 7: Top and bottom parts of the box test

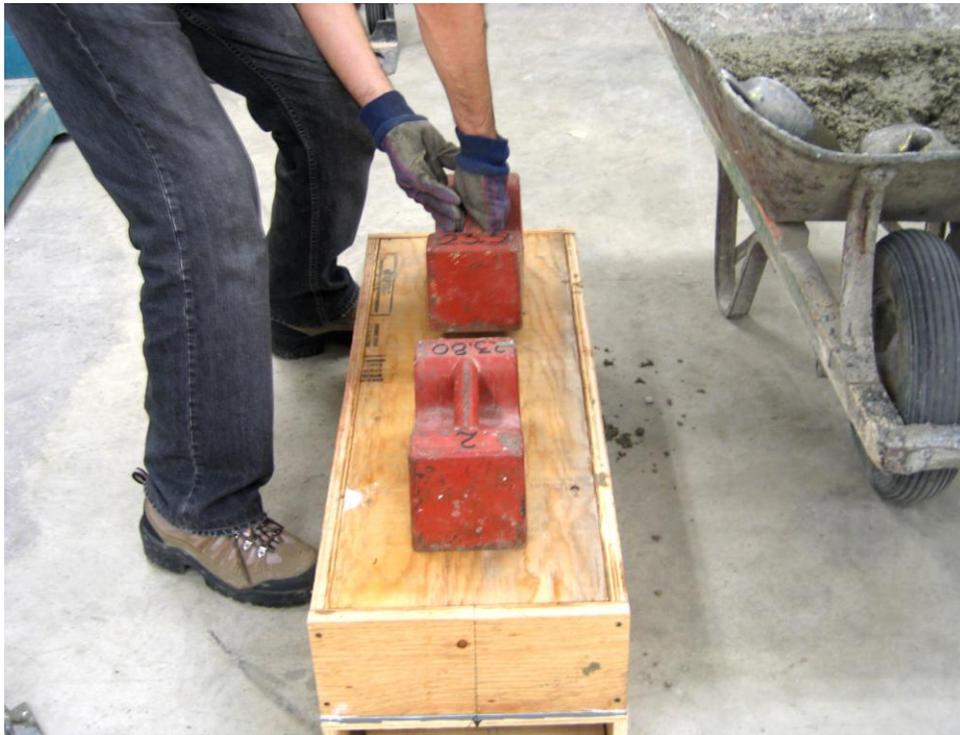
Figure 10: Extra pressure on fresh concrete to accelerate the bleeding process

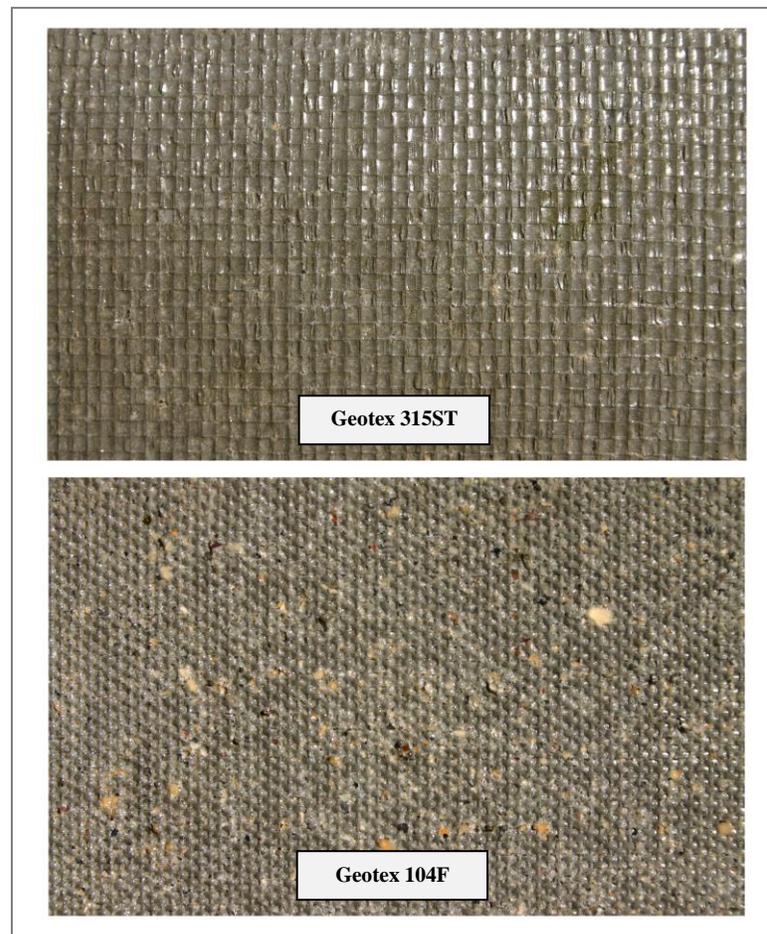
Figure 13: Comparison between the textures produced by different fabrics

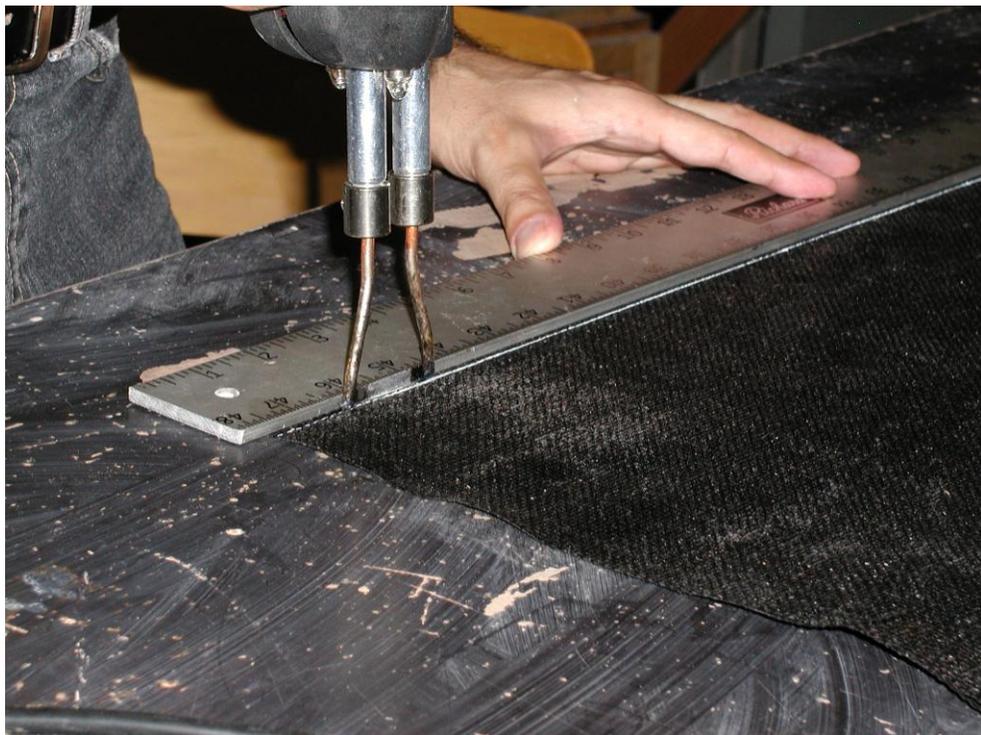
Figure 18: Soldering gun with the blade-shaped tip melting fabric and providing straight edge

A simple formwork was designed and built to form concrete cylinders using fabric. In order to do so, the fabric needed to be cut to size. Woven geotextiles can be cut using scissors or a knife edge though edge fraying may occur. To avoid edge fraying, fabric pieces were cut using a soldering gun. A blade-shaped tip and an aluminum straight edge were used to be able to follow straight lines when cutting (Figure 17 and Figure 18). By using a soldering gun to cut the fabric by melting, the fraying problem was completely avoided and sharp, straight edges were provided for the fabric samples. Cut fabrics were then sandwiched and bolted between two pieces of plywood. Plywood pieces were made wide enough to support and hold the fabric in between and resist the possible tension created in the fabric mold due to the hoop pressure created by the fresh concrete.

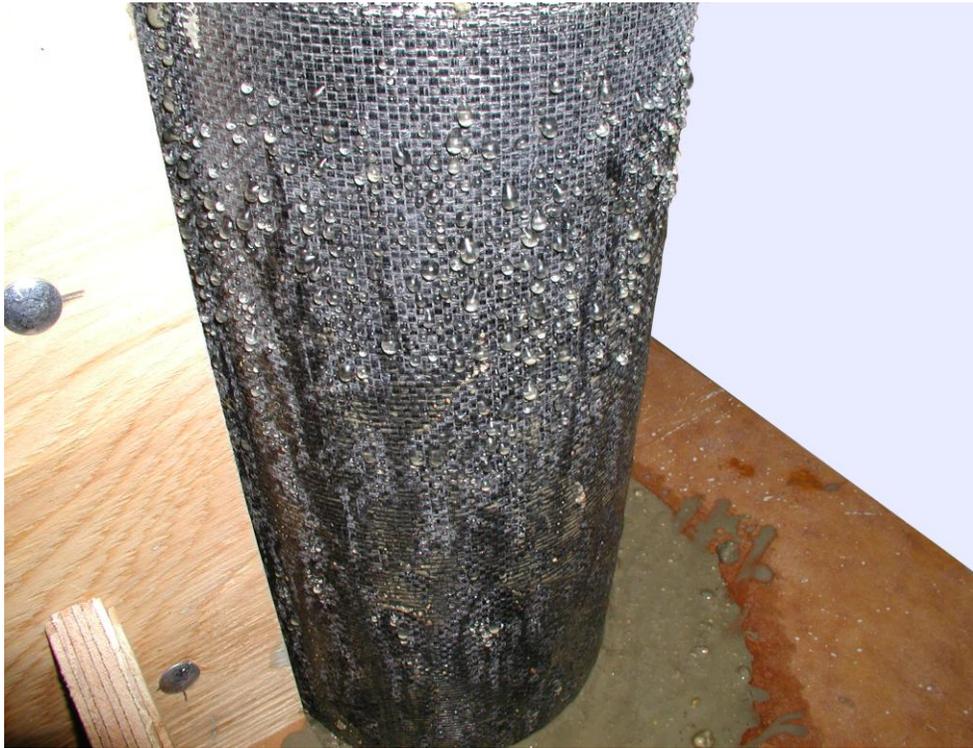
Figure 23: Bleed clear water from the walls of a 152 mm (6 in.) diameter fabric-formed concrete cylinder

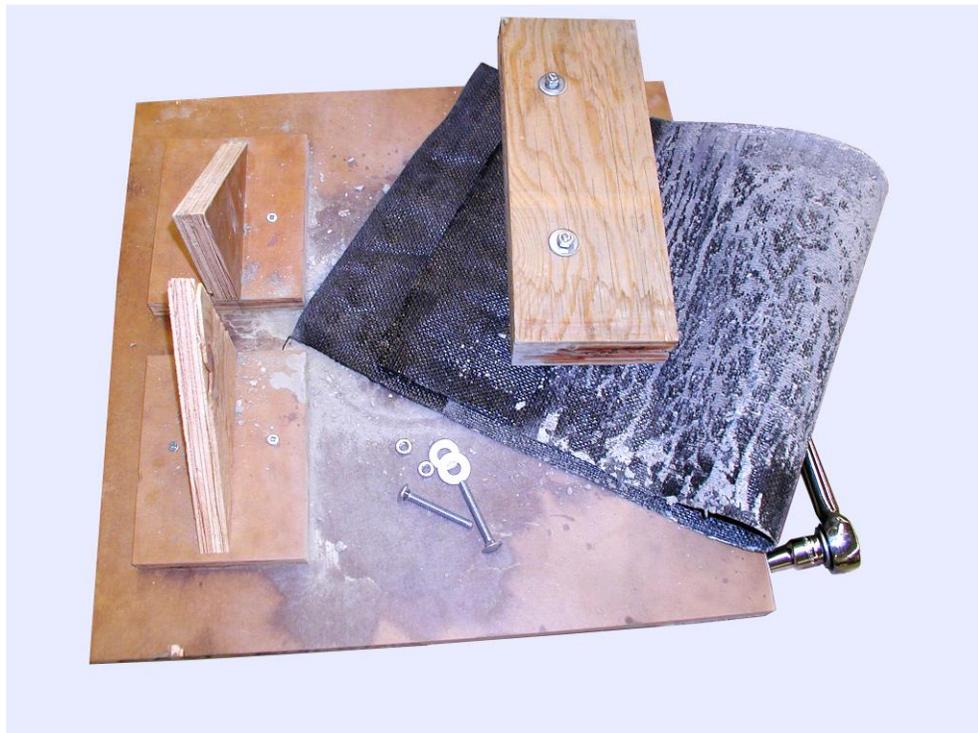
Figure 25: Reusable fabric form parts; the base, sandwich boards, bolts, and the fabric itself

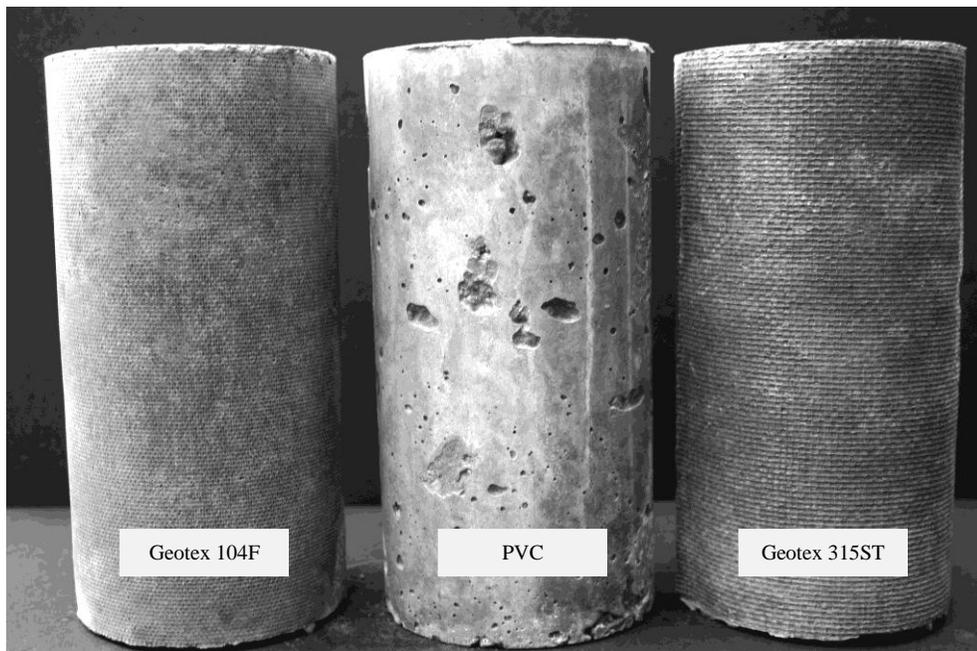
When visually inspected, the surface of the specimens formed with fabric had a finely textured surface imprint. Unlike PVC formed samples, no large aggregate or bug holes were visible on the concrete surface. Figure 37 shows three cylinders cast from left to right, Geotex 104F, PVC and Geotex 315ST.

Figure 37: The effect of mold on quality of quality of concrete finish

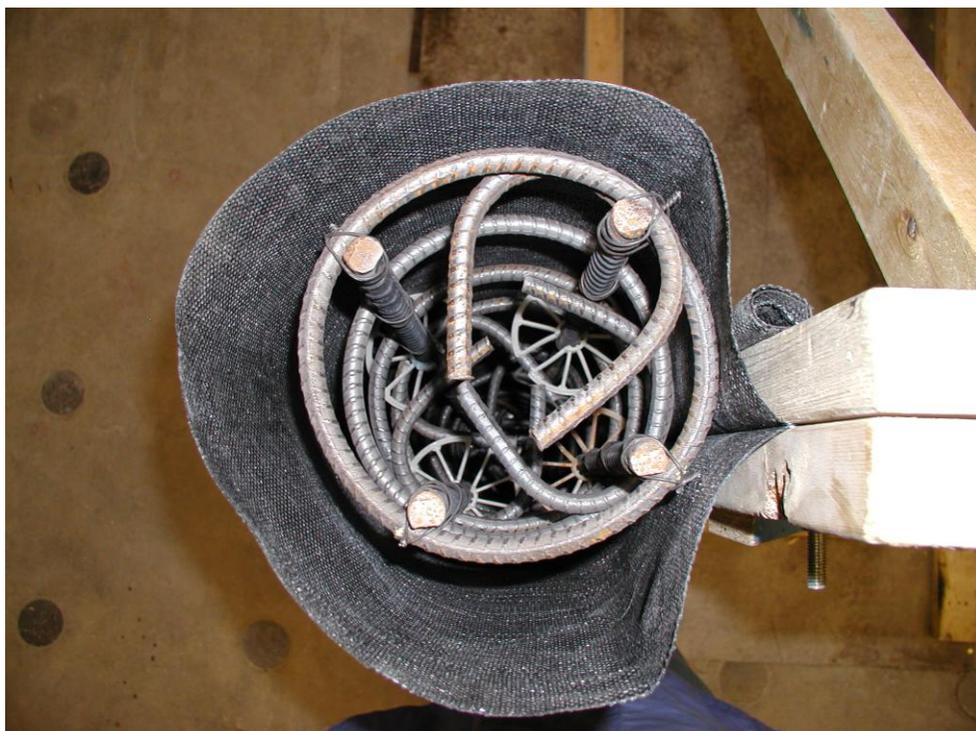
Figure 46: Reinforcement cage

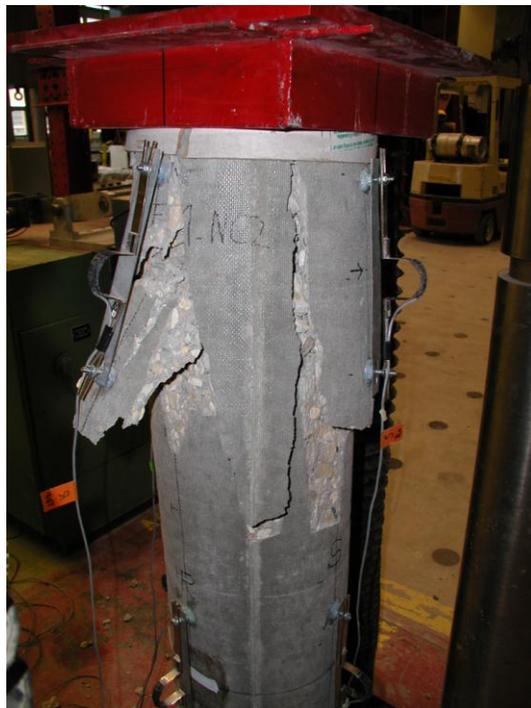
Flaking and surface concrete delamination observed in the failure of both fabric-formed columns also confirms that the surface of the concrete cast in fabric formwork was more brittle than concrete cast in conventional formwork. The change in Poisson's ratio was also studied when these columns were tested. The value was derived from dividing the average value of the data from two circumferential strain gauges placed at 180° apart from one another, by their corresponding axial pi-gauges. Both flyash and normal concrete fabric formed columns, proved to have lower Poisson's ratio value which is another indication of brittleness and less surface deformation in the fabric-formed specimens. It is necessary to mention that it is nearly impossible to form a perfectly straight column using handmade fabric column formwork, so very small values of eccentricity in loading condition may occur. Since small values of the eccentricity do not create large moment values at end portion of the columns, the effects of small eccentricities can be neglected (Bazant and Kwon 1994).

Figure 64: Column FF-NC-2 after failure

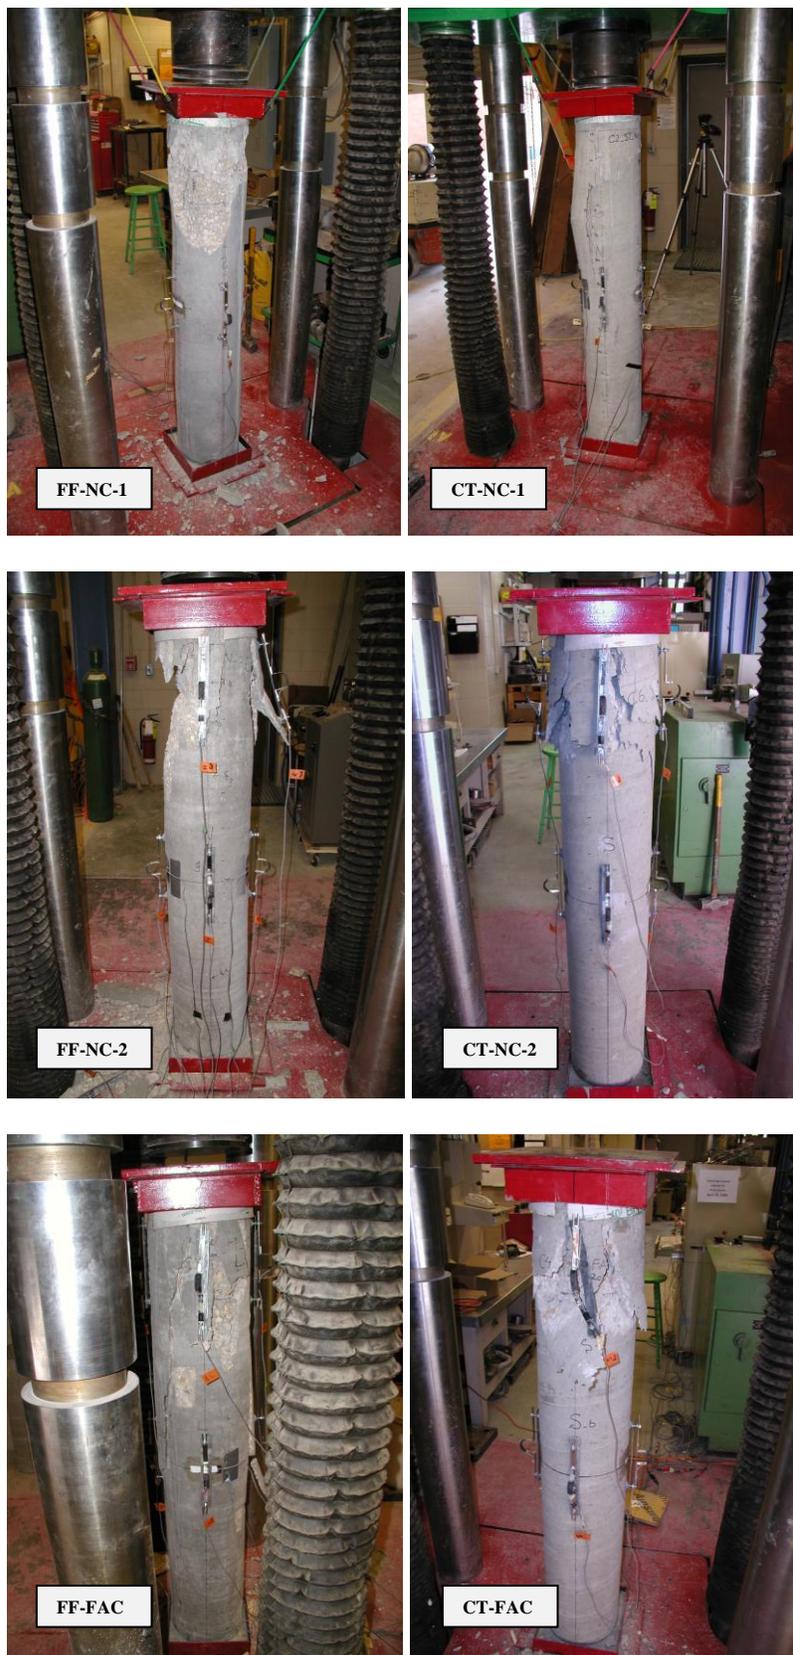
on top and then spalling till failure. Cardboard-formed columns presented a typical gradual failure with no sign of brittleness, no longitudinal cracks and no flaking. On the other hand, fabric-formed columns started with crushing on top and development of longitudinal cracks at the same time along with spalling. Also, some flaking and relative sudden failure of outside surface was observed. Photographs of these column failures are shown in Figure 65 (page 82).

Figure 65: All columns after failure

In each concrete type, both fabric-formed columns withstood the same axial load level as the cardboard formwork control samples. All samples failed at the top portion. At the extreme top portion of a concrete column, a permeable fabric mold does not lose appreciably more water than a conventional formwork or a cardboard tube. Therefore, in columns cast with the similar type of concrete, regardless of formwork material, strength of the concrete at top zone always remains the same and constitutes the area of weakest concrete in each column.

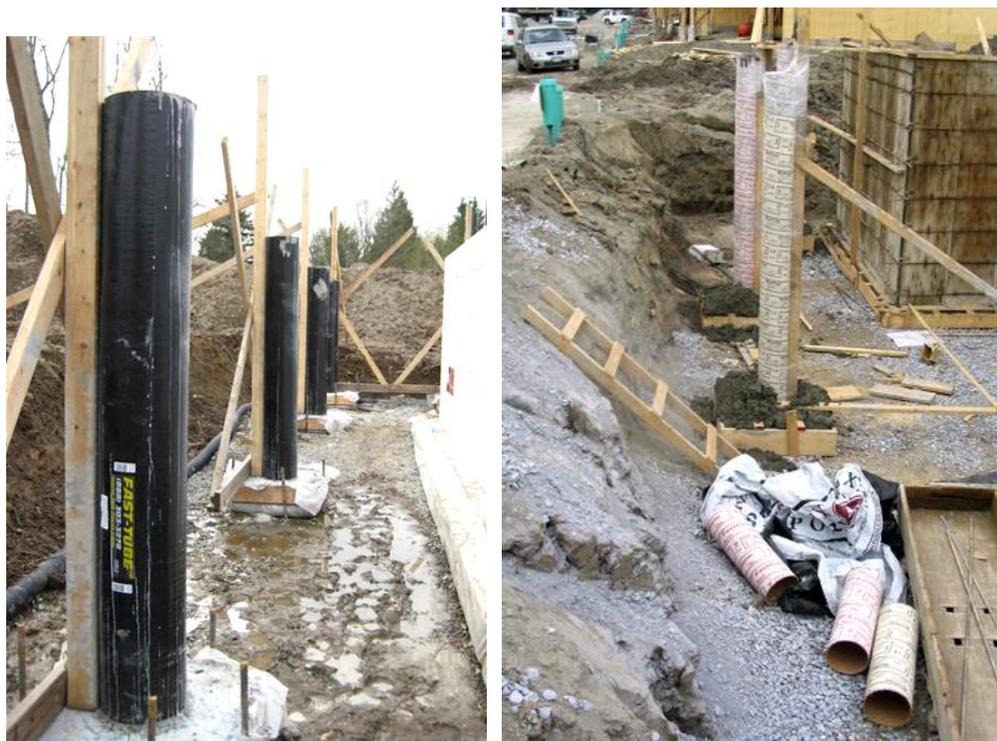
Figure A1: Commercially available column fabric formwork called Fast-Tube™ (left) and conventional cardboard formworks (right) on a job site
