## Appendix C: Results from Rebound Tests (Schmidt Hammer Tests)

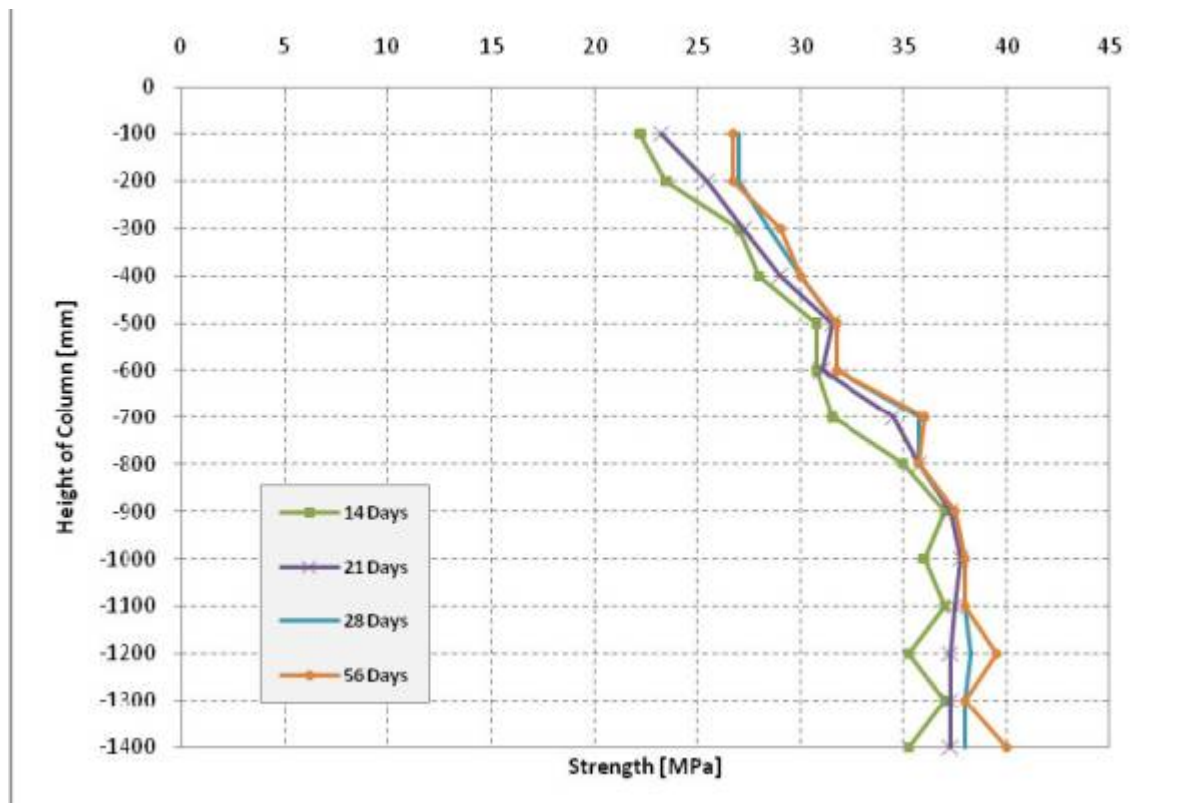
Figure C1: Column C1 – Fabric Formwork, Normal Concrete.

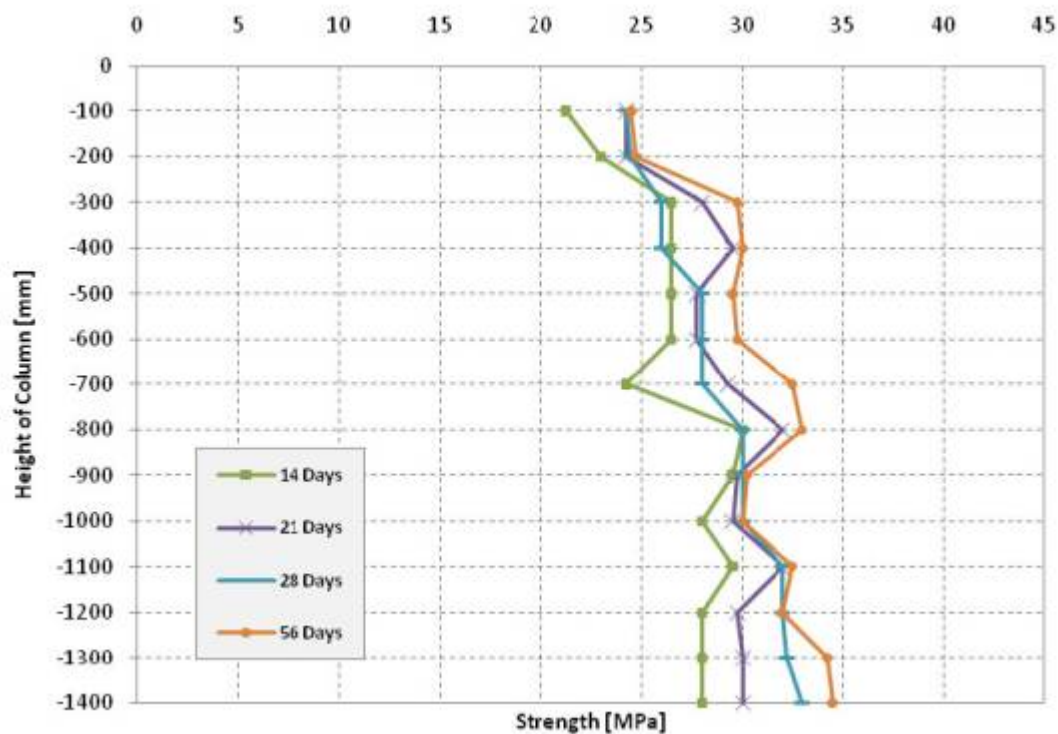
Figure C2: Column C2 - Cardboard Tube, Normal Concrete.

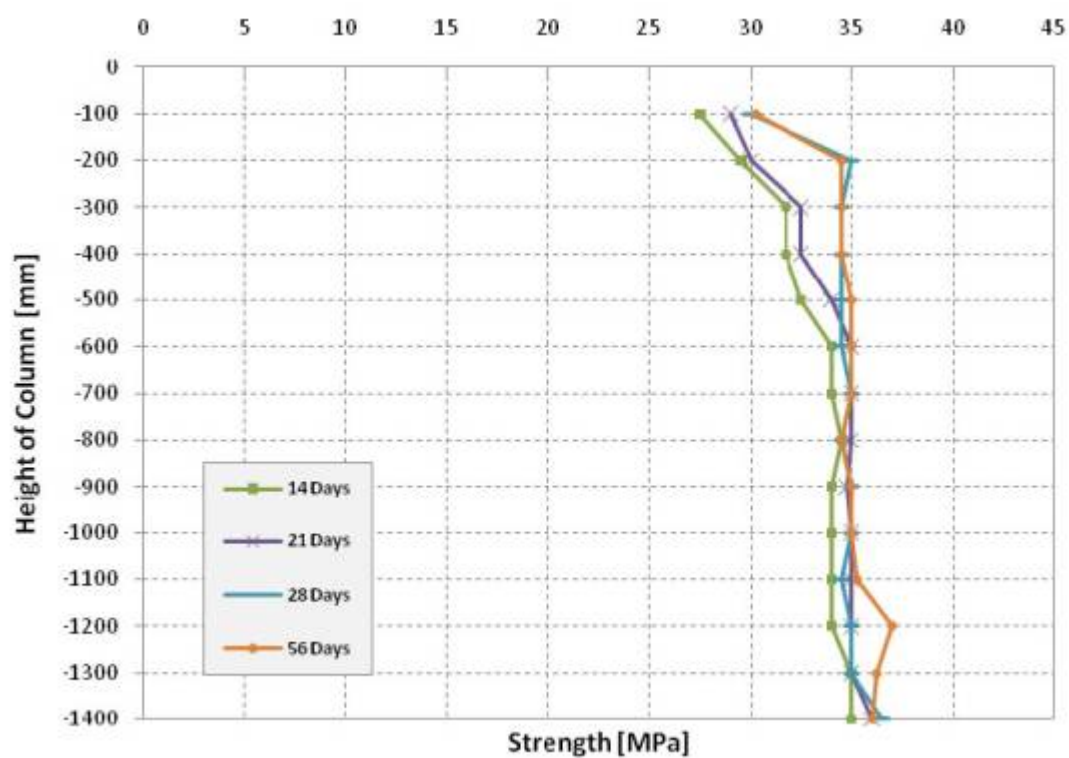
Figure C3: Column C3 - Fabric Formwork, Flyash Concrete.

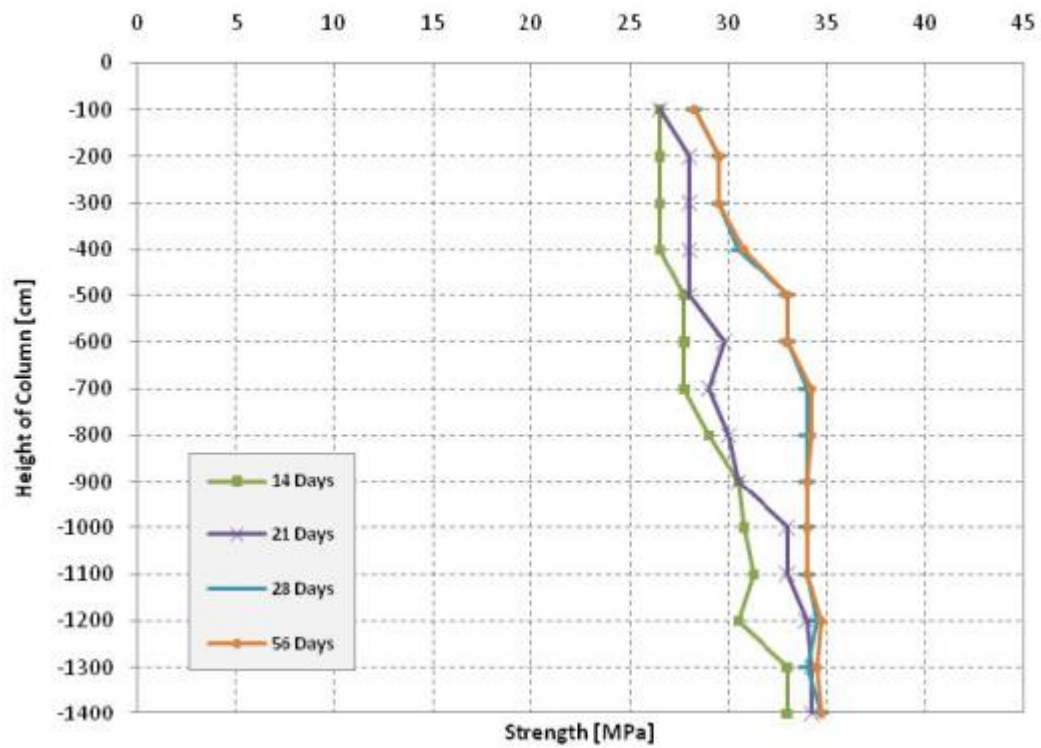
Figure C4: Column C4 - Cardboard Tube, Flyash Concrete.

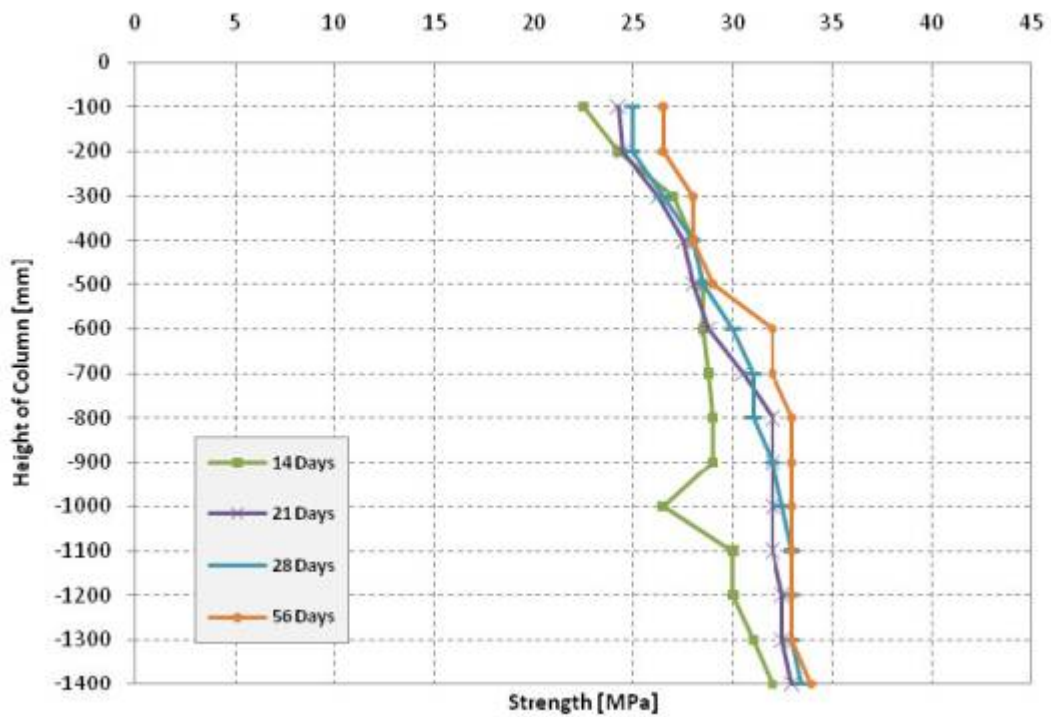
Figure C5: Column C5 - Fabric Formwork, Normal Concrete.

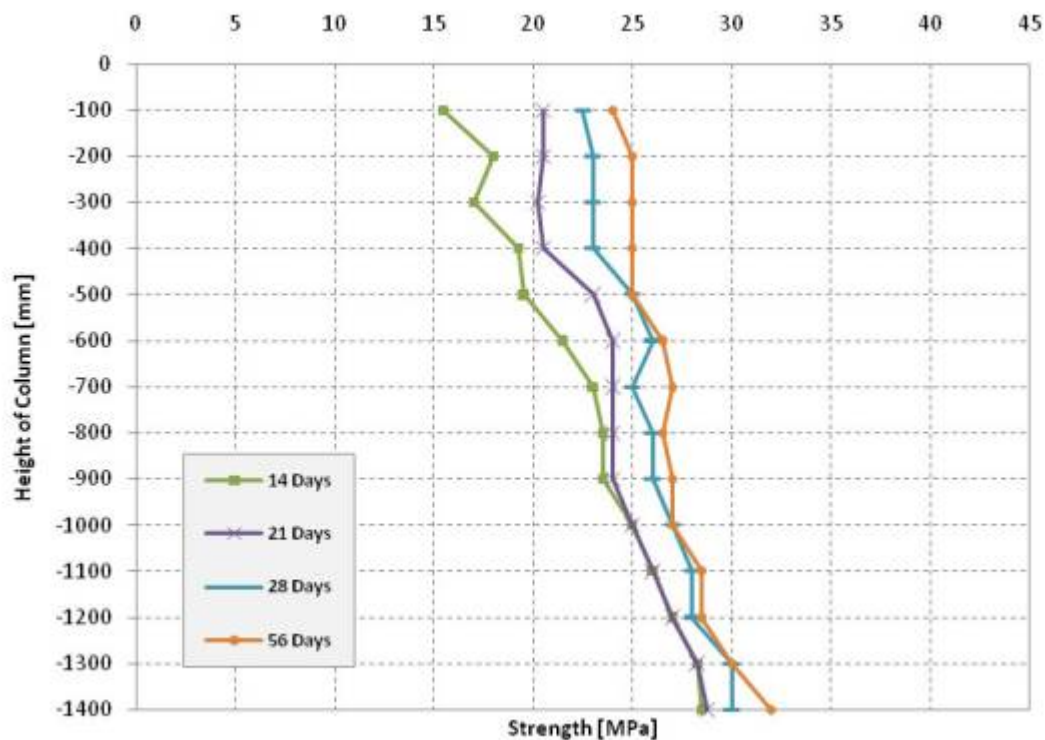
Figure C6: Column C6 – Cardboard Tube, Normal Concrete.
